**Analysis of Distress Along U.S. 331, Montgomery, AL
Between Mile Markers 88.480 and 91.070**

A thesis submitted to the Graduate Faculty of
Auburn University
in partial fulfillment of the
requirements for the Degree of
Master of Science

Auburn, Alabama
May 5, 2013

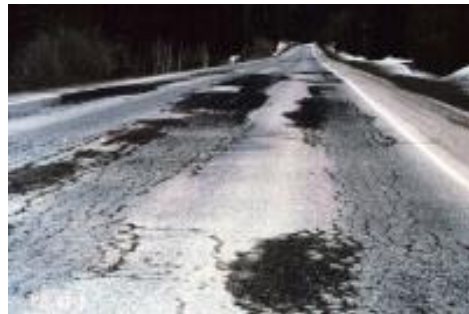
Figure 1: Fatigue cracking caused by frost action (Hoffman and Muench 2011)

There are two types of repairs for fatigue cracking based on the severity of the distress. For localized fatigue cracking, the distressed pavement should be removed and the underlying soils should be removed and replaced with a more suitable materials followed by recompaction and an asphalt patch. For large areas of fatigue cracking, problematic soils should be replaced and an asphalt overlay of adequate thickness to provide full structural support for the traffic loading should be applied over the entire pavement surface. Adequate drainage should be ensured so that the structural support of the base, subbase, and subgrade remains intact (Hoffman and Muench 2011).

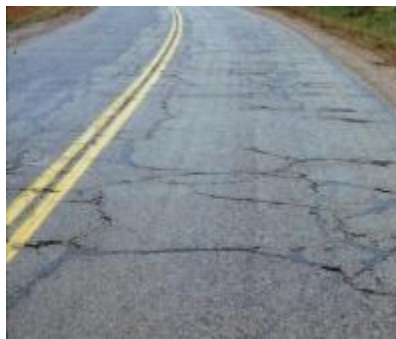
Figure 2: Block cracking (Hoffman and Muench 2011)

Repair is dependent upon the severity of the cracking. Cracks less than half an inch wide should be sealed with asphalt to prevent moisture from reaching the subgrade as well as the deterioration of the crack edges. Pavements with cracks greater than half an inch wide should be removed and replaced with a new asphalt surface (Hoffman and Muench 2011).

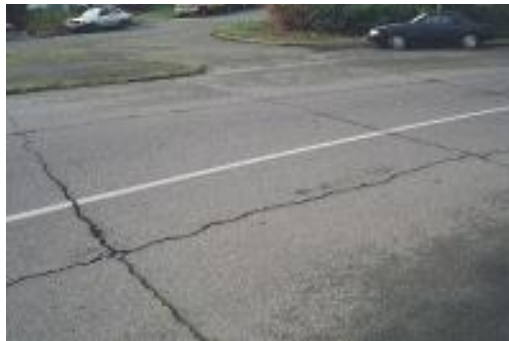
Figure 3: Joint reflection cracking (Hoffman and Muench 2011)

Repair is dependent upon the severity of the cracking. Cracks less than half an inch wide should be sealed to prevent moisture from reaching the subgrade as well as the deterioration of the crack edges. Pavements with cracks greater than half an inch wide should be removed and replaced with a new asphalt overlay (Hoffman and Muench 2011).

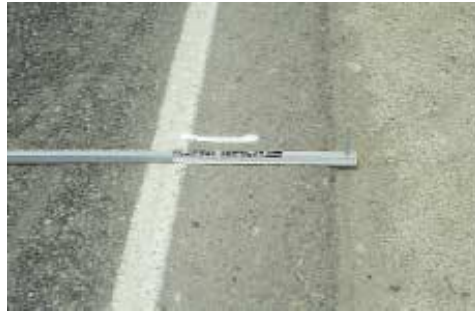
Figure4: Lane/Shoulder Elevation Differential (FHWA 2003)

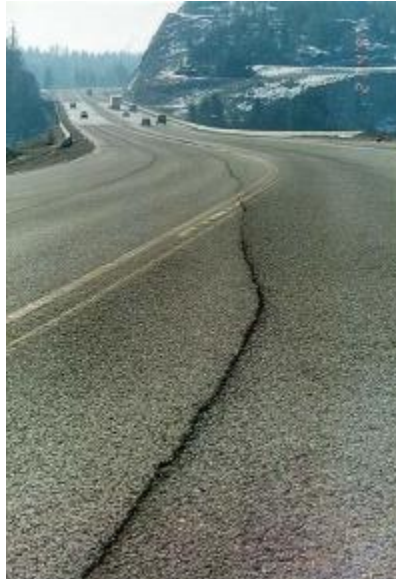
Figure5: Longitudinal crack as a result of poor joint construction (Hoffman and Muench 2011)

Repair is dependent upon the severity of the cracking. Cracks less than half an inch wide should be sealed to prevent moisture from reaching the subgrade as well as the deterioration of the crack edges. Pavements with cracks greater than half an inch wide should be removed and replaced with a new asphalt overlay (Hoffman and Muench 2011).

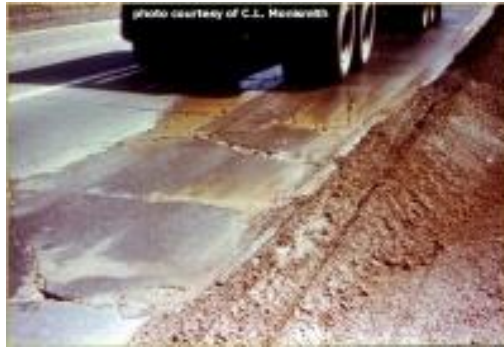
Figure 6: Pumping as a result of vehicular loading (Hoffman and Muench 2011)

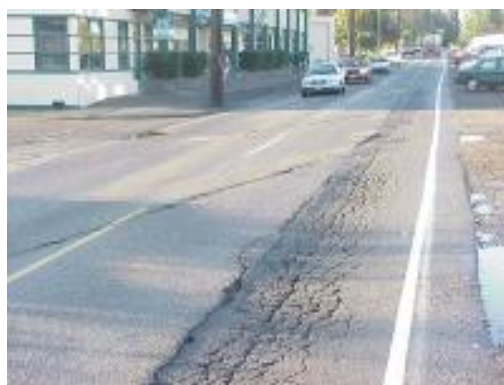
Figure 7: Rutting with fatigue cracking (Hoffman and Muench 2011)

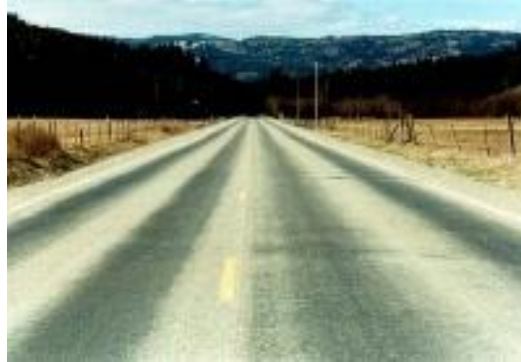
Figure 9: Bleeding in the wheelpaths (Hoffman and Muench 2011)

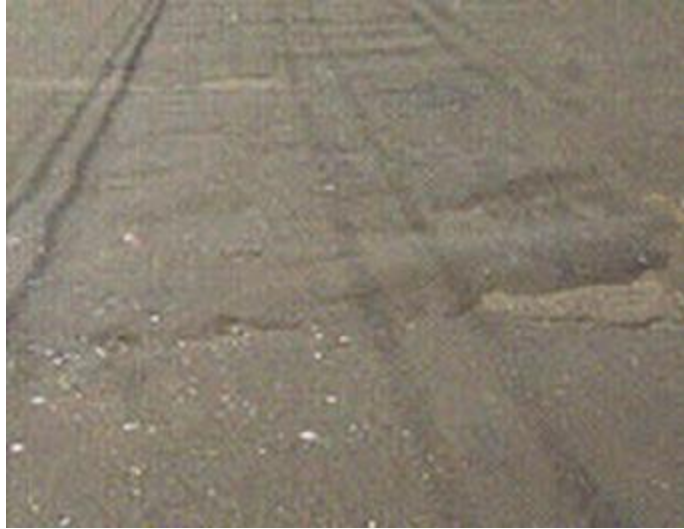
Figure 10: Corrugation (Halifax Regional Municipality 2012)

To repair a corrugated pavement, the damaged section should be removed and overlaid with a new asphalt surface course (Hoffman and Muench 2011).

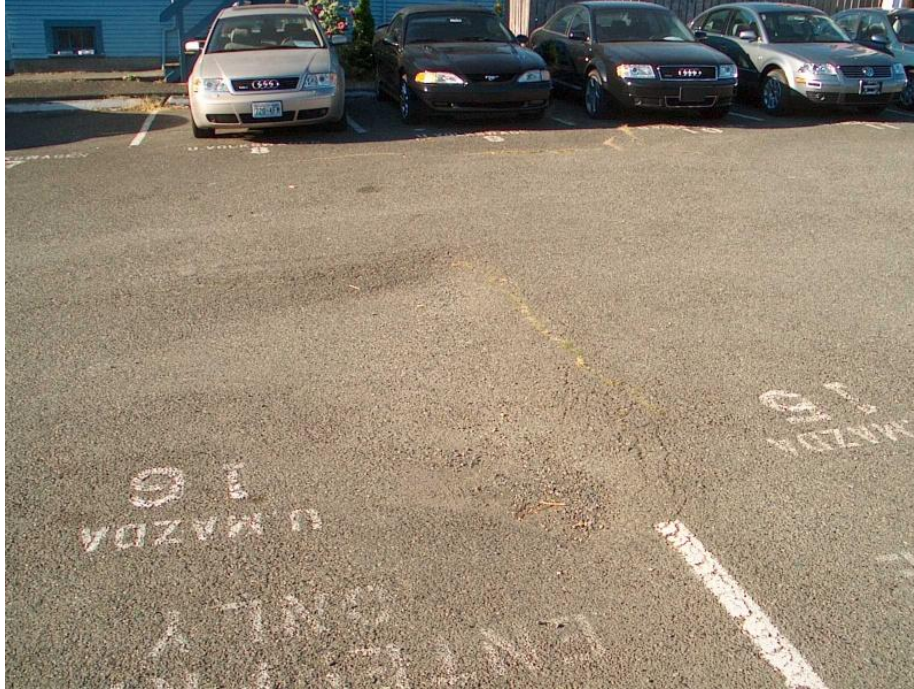
Figure 11: Depression (Hoffman and Muench 2011)

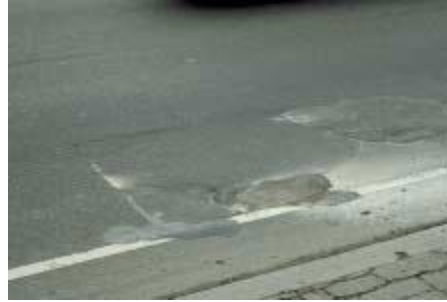
Figure 12: High severity patching (FHWA 2003)

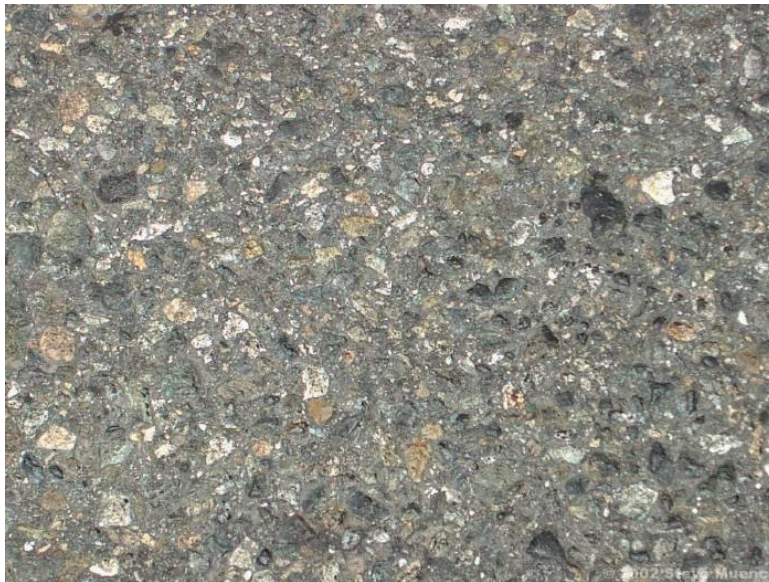
Figure 13: Polished aggregate (Hoffman and Muench 2011)

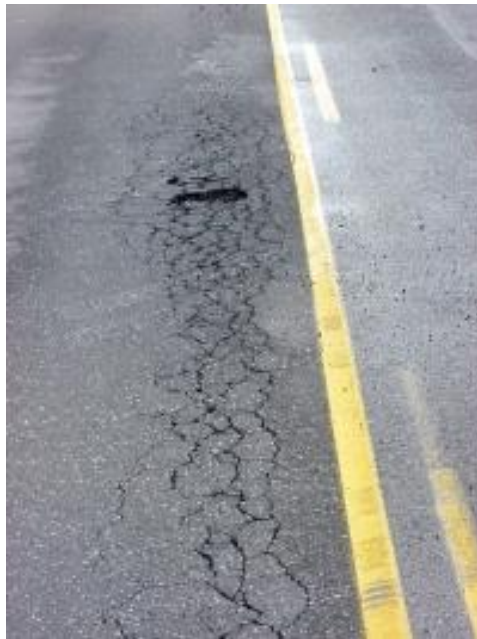
Figure 14: Pothole as a result of fatigue cracking (Hoffman and Muench 2011)

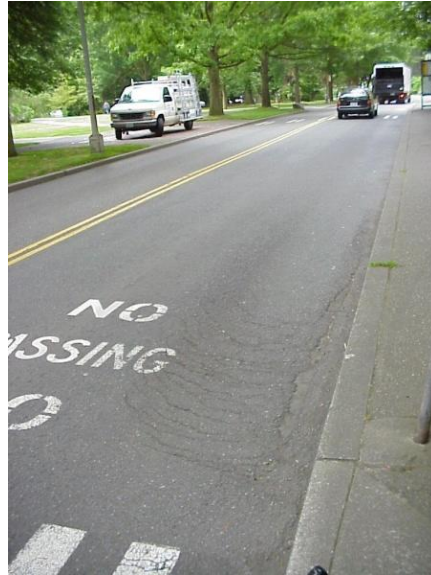
Figure 16: Slippage cracking (Hoffman and Muench 2011)

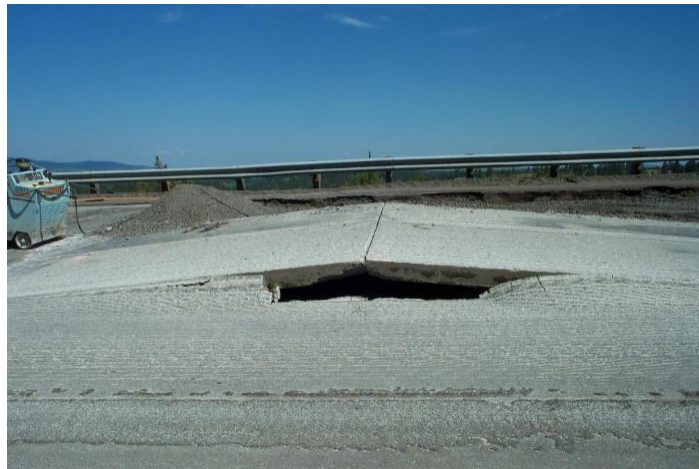
Figure 17: Blowup on SR 195 in eastern Washington (Hoffman and Muench 2011)

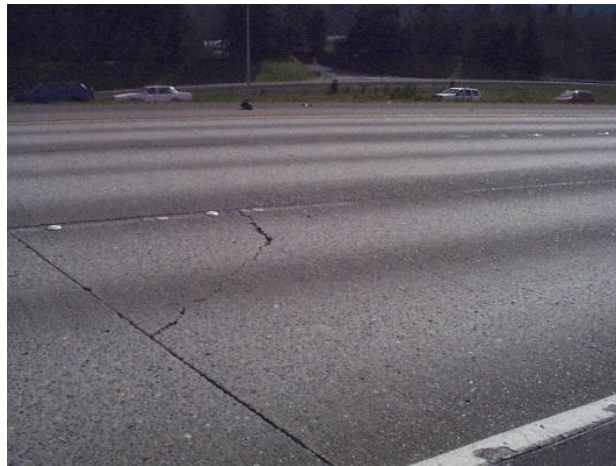
Figure 18: Corner break (Hoffman and Muench 2011)

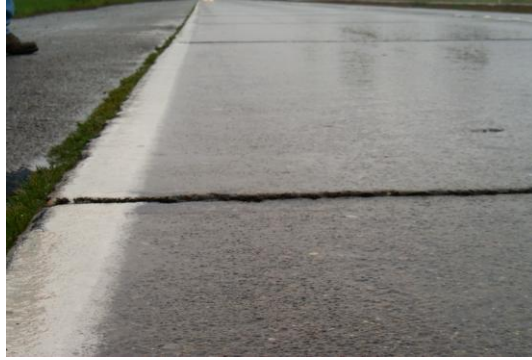
Figure 19: Faulting of a transverse joint (Hoffman and Muench 2011)

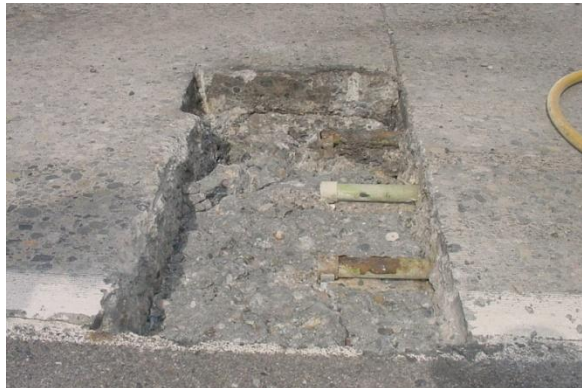
Figure 20: Dowel corrosion causing joint load transfer system failure (Hoffman and Muench 2011)

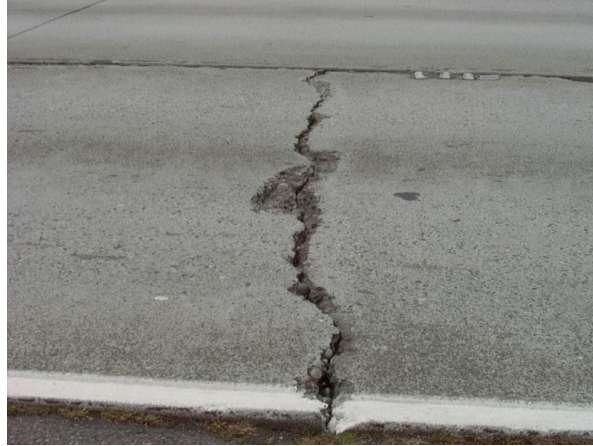
Figure 21: Crack spalling (Hoffman and Muench 2011)

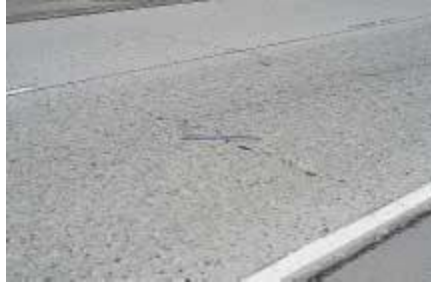
Figure 22: High severity transverse cracking (FHWA 2003)

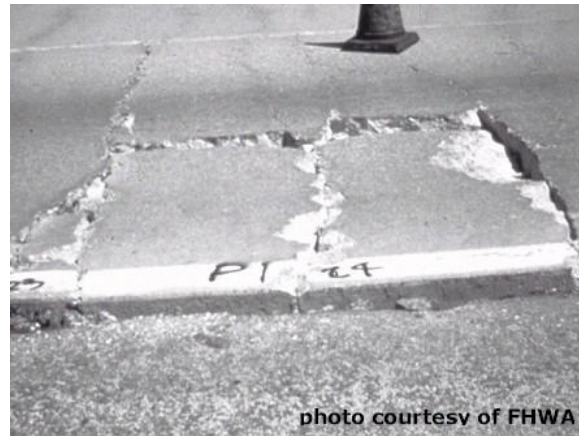
Figure 23: Edge punchout (Hoffman and Muench 2011)

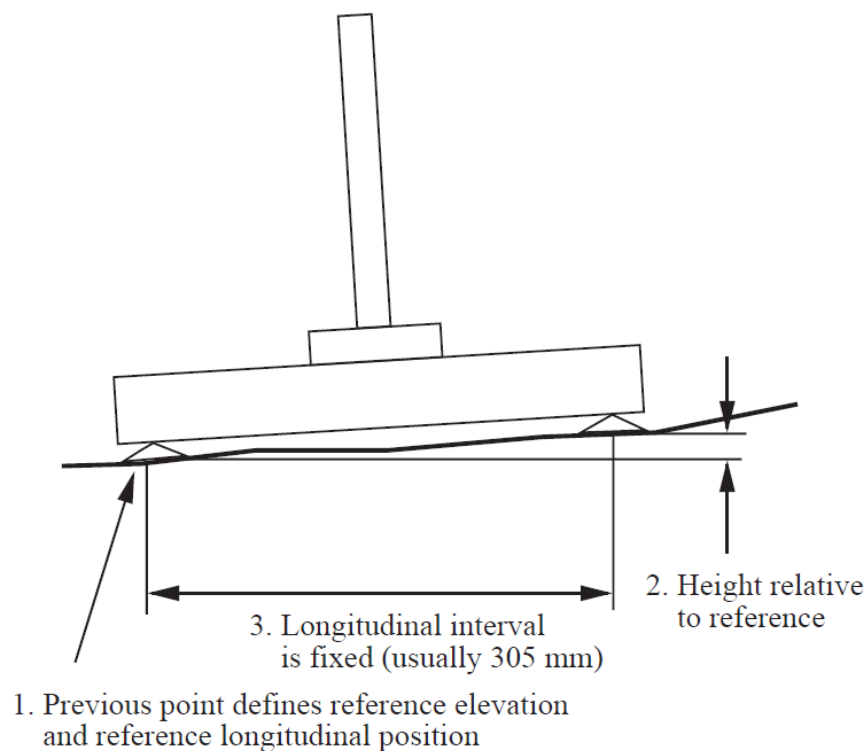
The Dipstick Profiler looks like an upside down “T” with a support at each end of the crossbar. The supports are spaced 305 mm apart and the elevation differential between these two supports is measured by a precision inclinometer. The data is recorded by an on-board computer. This device is used by positioning the crossbar of the upside down “T” along the desired profile line. The machine will beep when stable indicating that a reading has been recorded. After this reading has been taken, the machine should be pivoted 180 degrees about the leading support and when both supports are stable; the machine will record a reading and beep again. The machine should be “walked” in this manner until the desired profile length is achieved. The dipstick profiler provides a true roadway profile (Sayers and Karamihas 1998).

Figure 25: Dipstick Profiler (Sayers and Karamihas 1998)

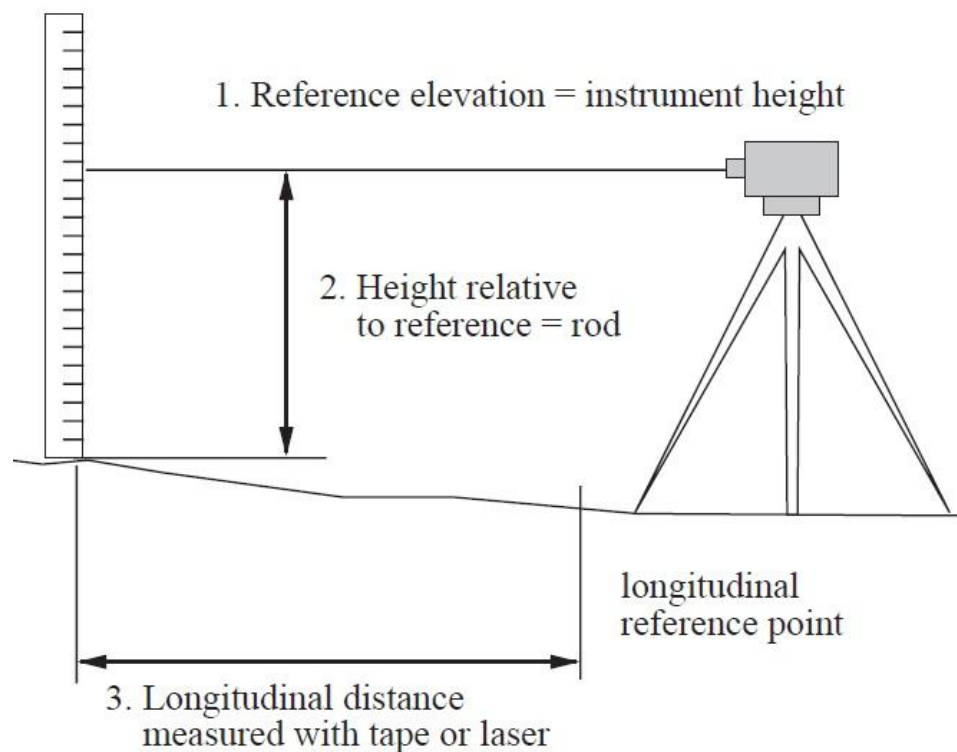
Longitudinal surveys are performed using a rod, level, and tape. The rod and level are used in conjunction to provide an elevation relative to a reference elevation. The tape is used to provide the horizontal distance of the elevation measurements relative to a reference point. The elevations and horizontal distance measurements are used in conjunction to provide a profile which in turn can be used to determine roughness. This method is seldom used for roughness evaluation because elevation measurements must be taken at very close intervals (1 ft.) and must be very accurate (within 0.5 mm) to provide sufficient data. Longitudinal surveys provide a true roadway profile. This is known as a static method because measurements are made with instruments that are not moving (Sayers and Karamihas 1998).

Figure 26: Rod and Level used for longitudinal surveys (Sayers and Karamihas 1998)

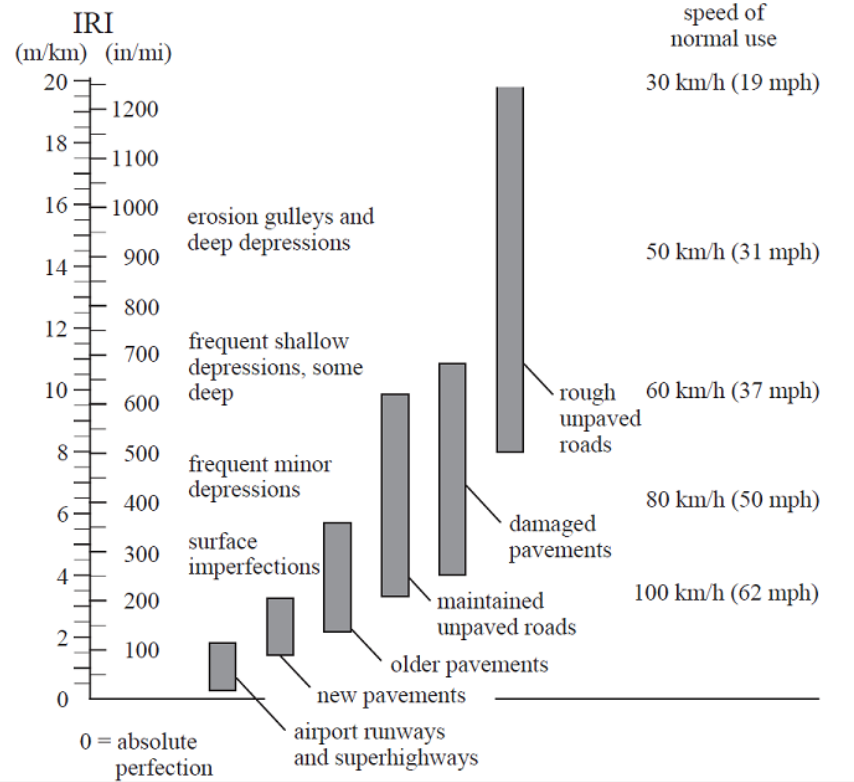
Figure 29: Typical IRI values for roadways (Sayers and Karamihis 1998)

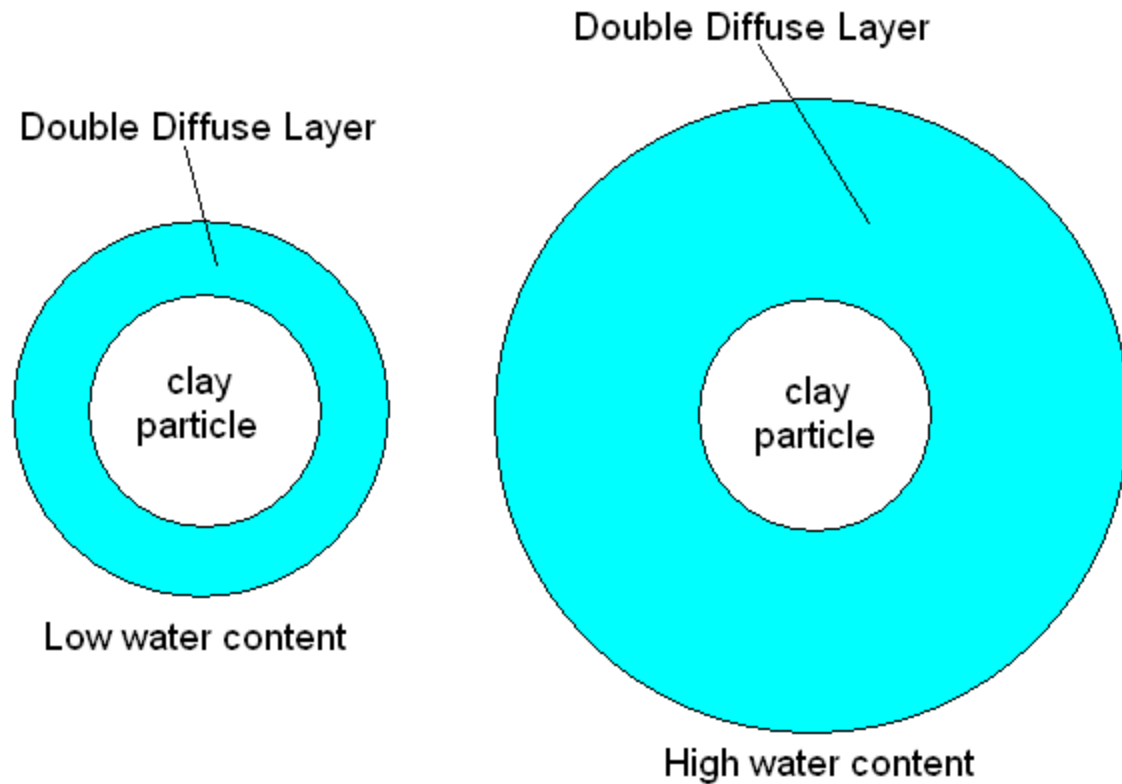
The mechanism of swell occurs when positively charged water molecules interact with negatively charged clay soil particles. This interaction results in a cation exchange and an attraction between the water molecules and the soil particles. This attraction of water molecules causes them to accumulate around the clay particle, resulting in a double diffuse layer surrounding the clay particle (Wersin et. al 2004). This double diffuse layer causes more water to be present in the pore spaces between clay particles resulting in an increase in pore pressure. If this pore pressure increase is greater than the surcharge pressure on the clay, swelling will occur until equalization of pore pressure and surcharge pressure is achieved. Available water molecules will continue to be attracted to the clay particles until the charge equilibrates. The condition where the charge equilibrates and water molecules are no longer attracted to the clay particles is known as the stability value of water content for the clay. When this stability value is reached, further increases in water content do not result in continued swell (McCarthy 2007). Figure 30 shows how increasing water contents affect the size of the double diffuse layer and the total volume of the clay.

Figure 30: Schematic of double diffuse layer size as it varies with water content.

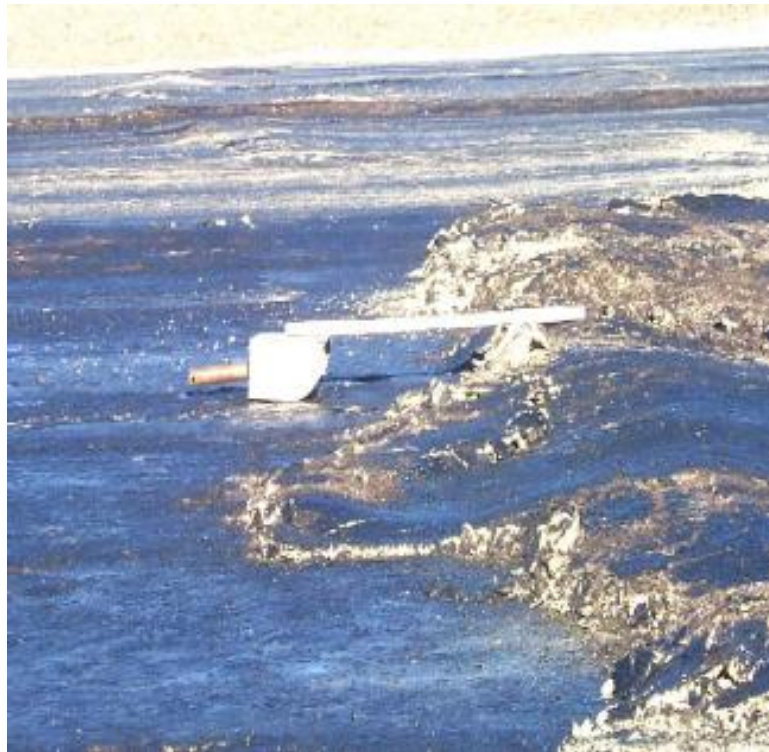
Figure 31: Heave caused by ettringite formation (Harris 2004).

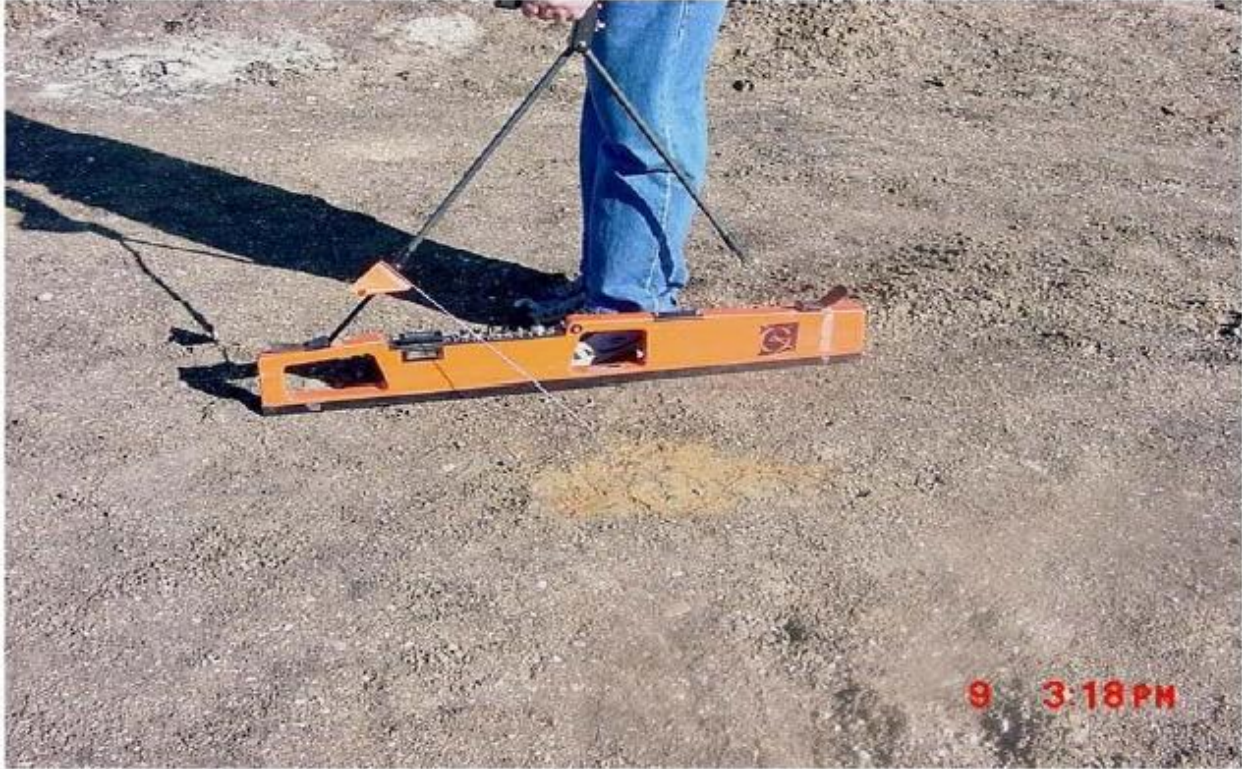
Figure 32: The EM 38 Magnetometer (Natarajan 2004).

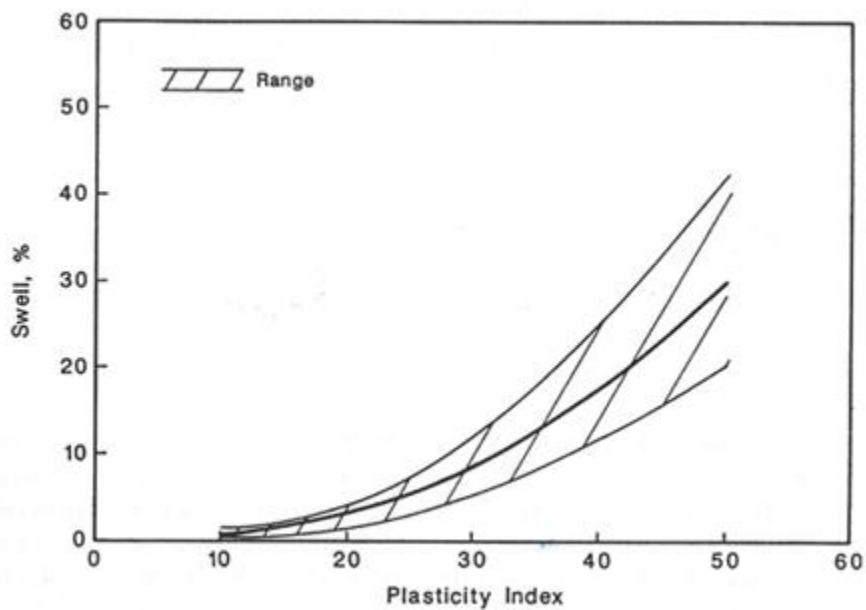
Figure 33: Typical relationship between swell and plasticity index (Little 1995).

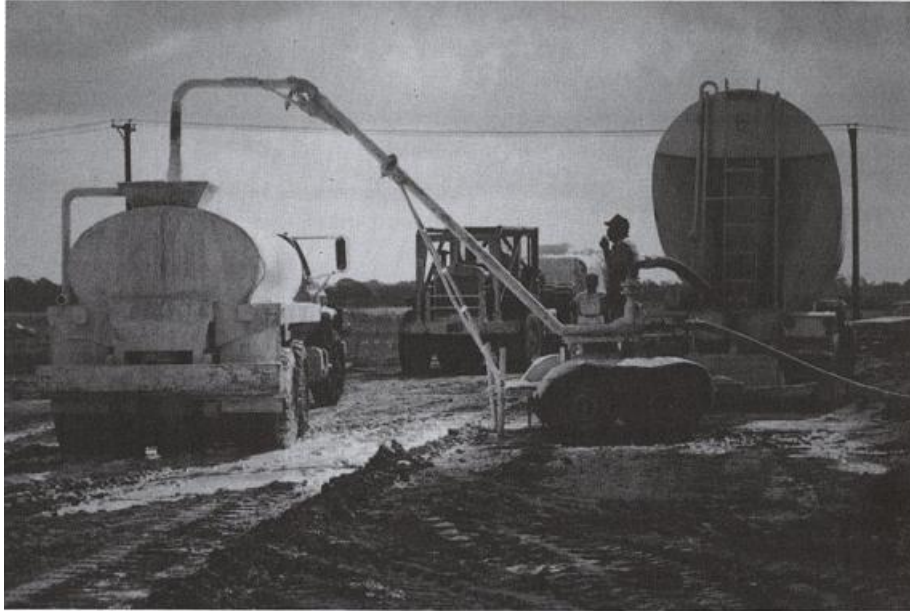
Figure 34: Lime slurry mixed with a jet mixer (Little 1995).

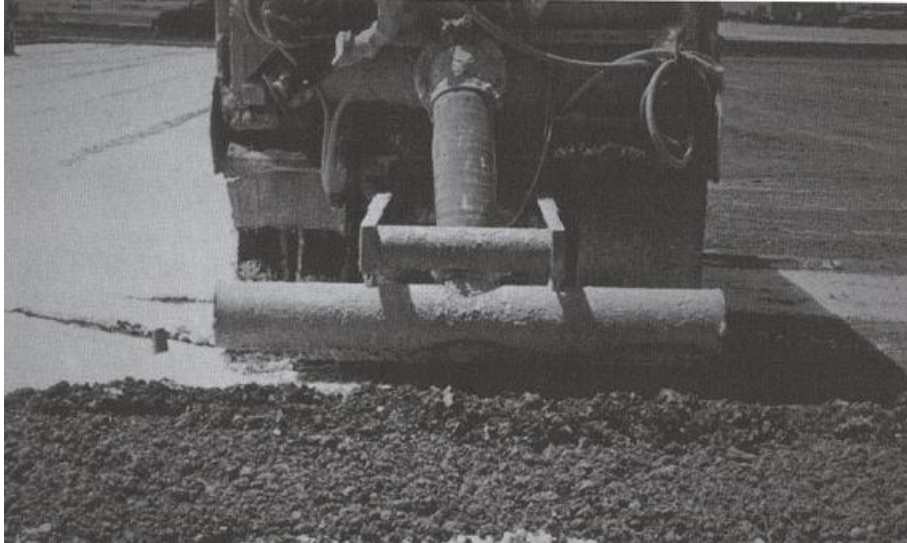
Figure 35: Pipe spreader bar used for spreading dry hydrated lime (Little 1995)

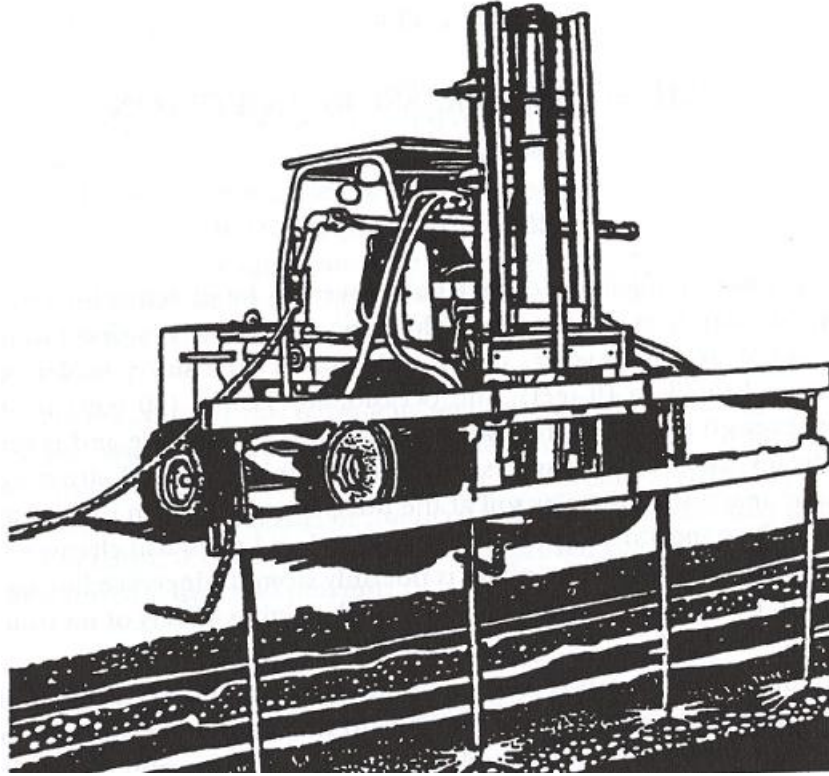
Figure 36: Typical machinery used for lime slurry pressure injection (Little 1995)

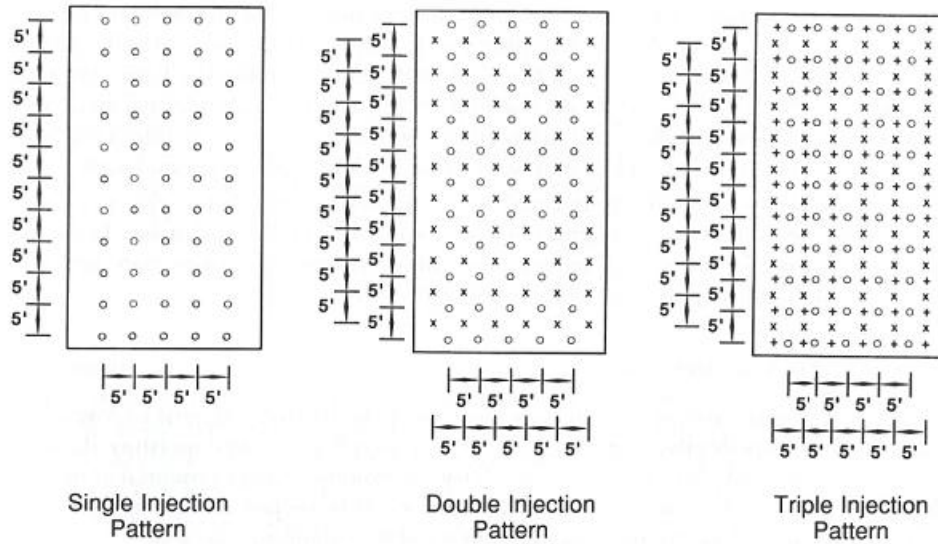
Figure 37: Typical grid patterns for single, double, and triple injection (Little 1995)

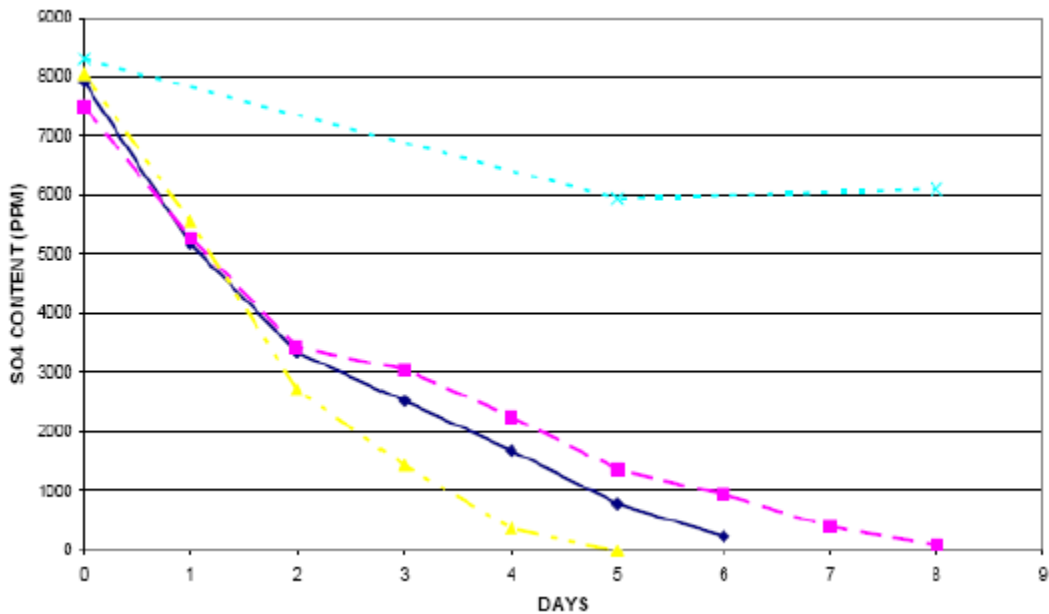
Figure 38: Effect of mellowing period on sulfate content (Little 2009).

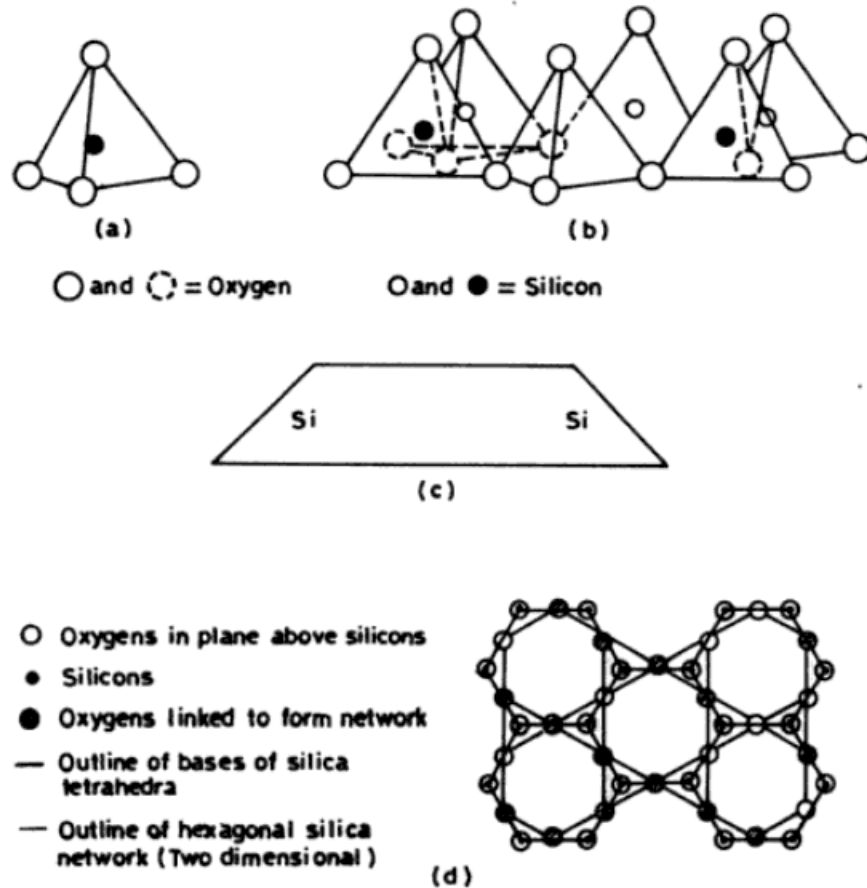
Figure 39: (a) Single silica tetrahedron. (b) Isometric representation of silica tetrahedral sheet. (c) Symbolic representation of silica tetrahedral sheet. (d) Top view of silica tetrahedral sheet (Ranjan 1991).

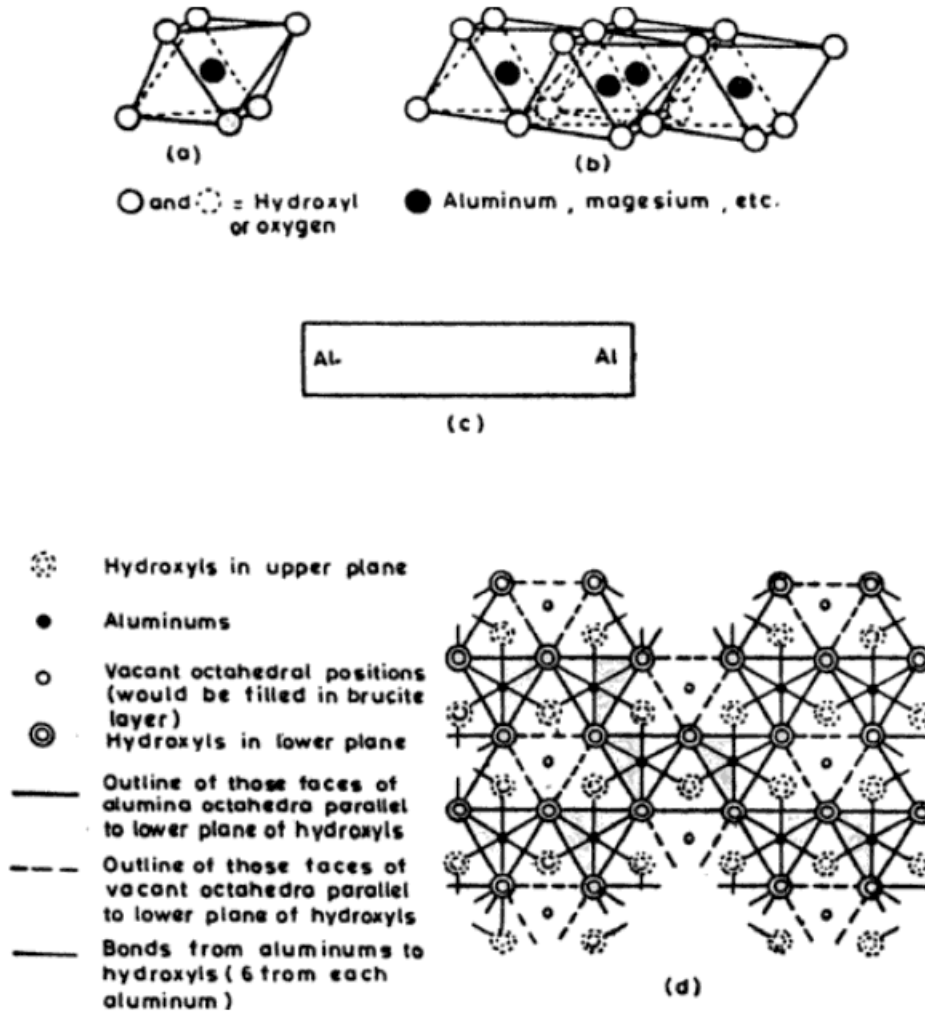
Figure 40: (a) Single aluminum octahedron. (b) Isometric representation of the aluminum octahedral sheet. (c) Symbolic representation of the aluminum octahedral sheet. (d) Top view of the aluminum octahedral sheet (Ranjan 1991).

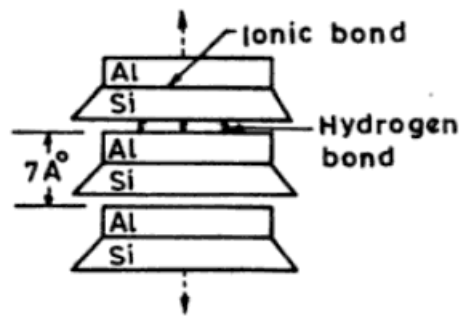
Figure 41: Schematic of the kaolinite structure (Ranjan 1991).

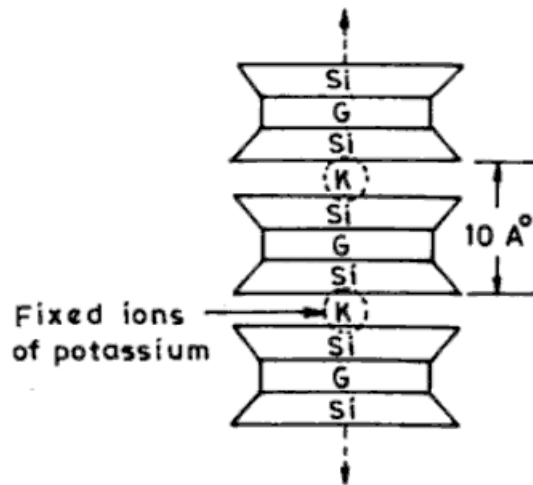
Figure 42: Representation of the illite structure (Ranjan 1991)

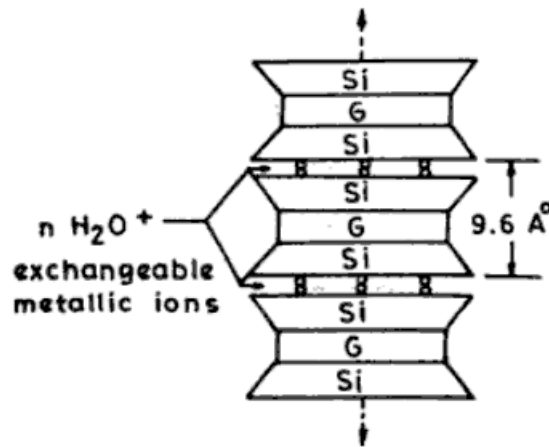
Figure 43: Diagram of the montmorillonite structure (Ranjan 1991).

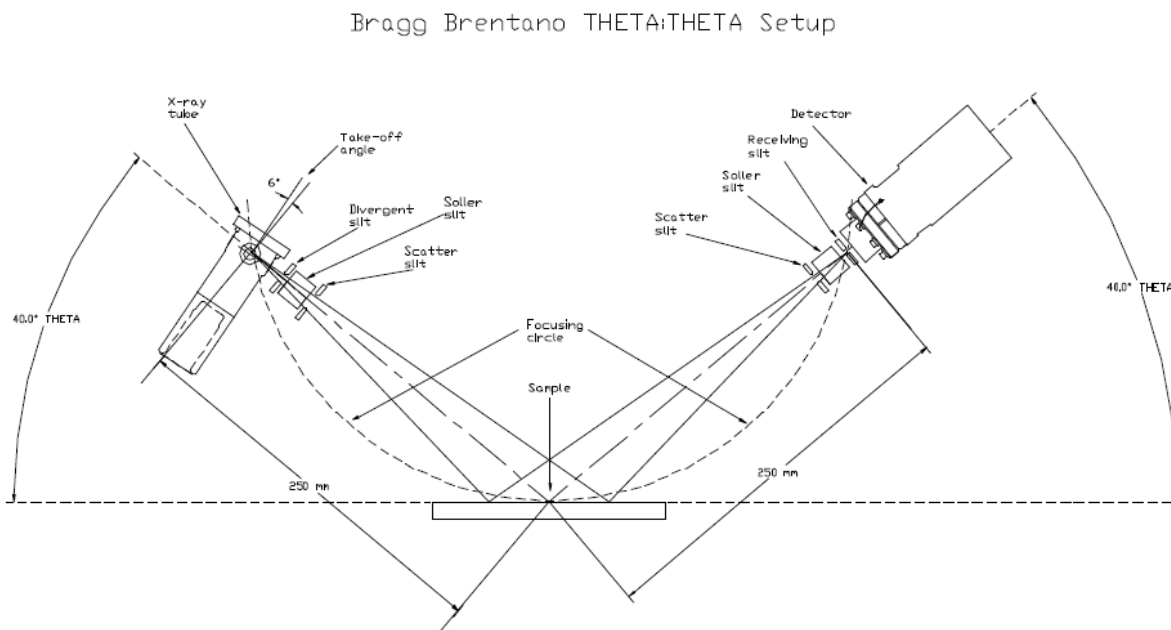
Figure 45: Bragg Brentano Theta : Theta goniometer setup (Scintag 1999).

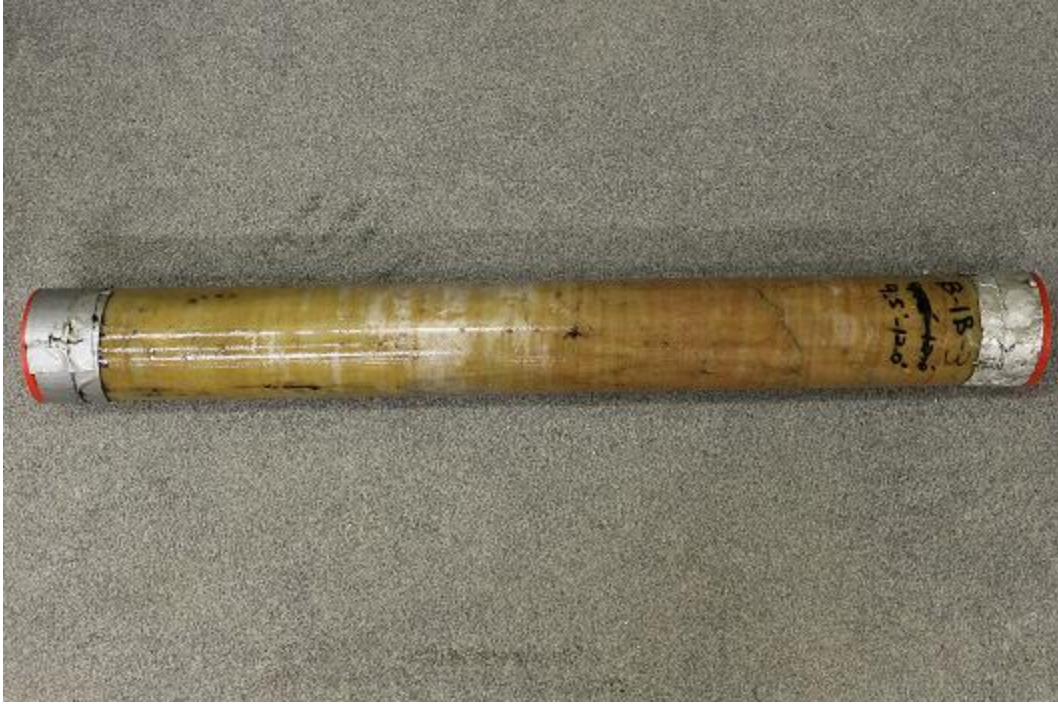
Figure 48: A continuous drilling sample in the plastic tube.

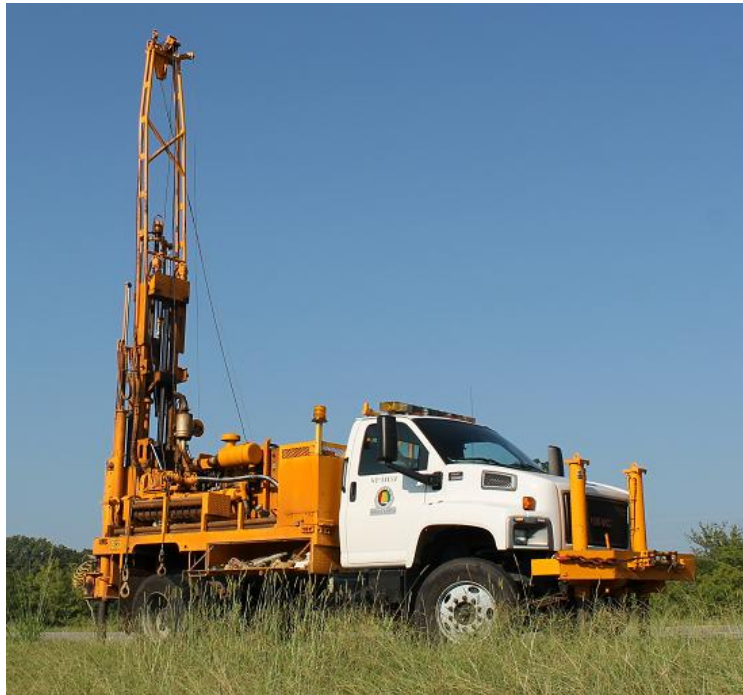
Figure 49: Drill rig used for sampling.

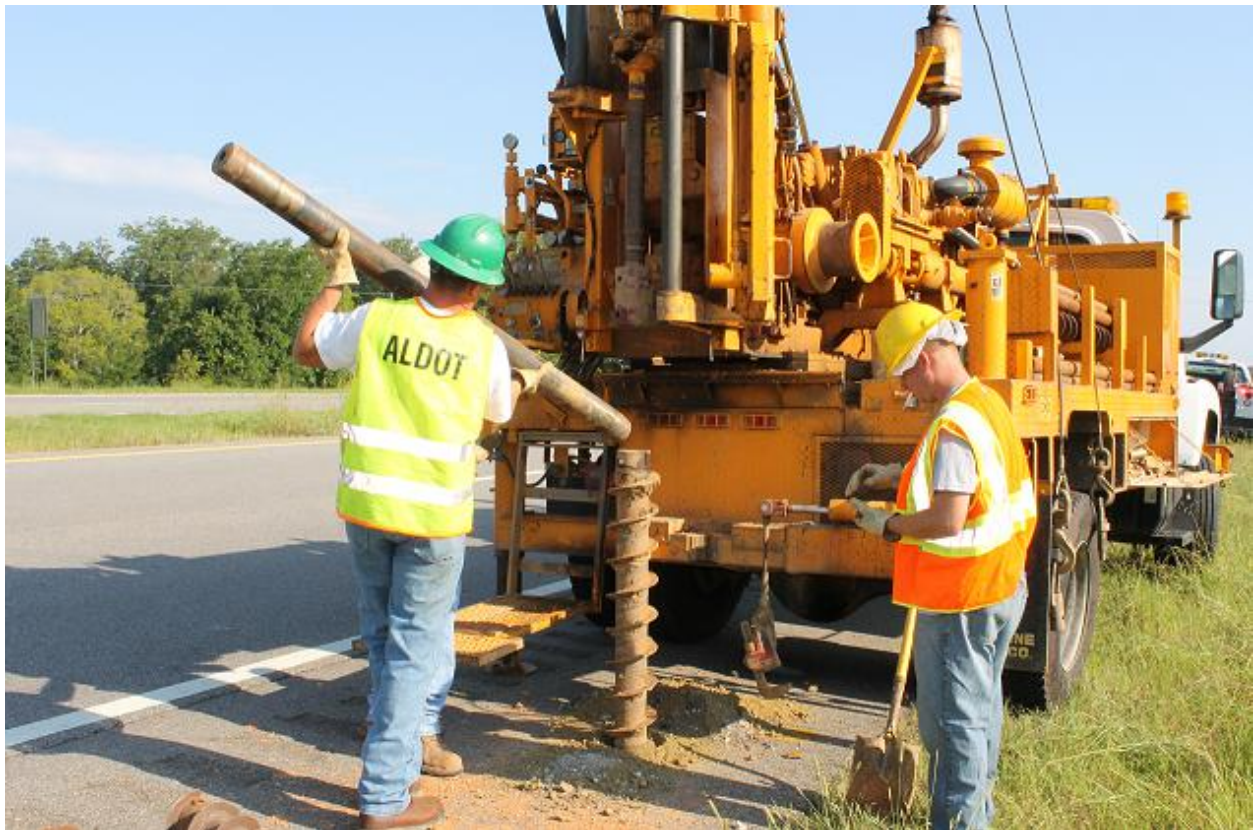
Figure 50: Inserting tubes into hollow stem auger.

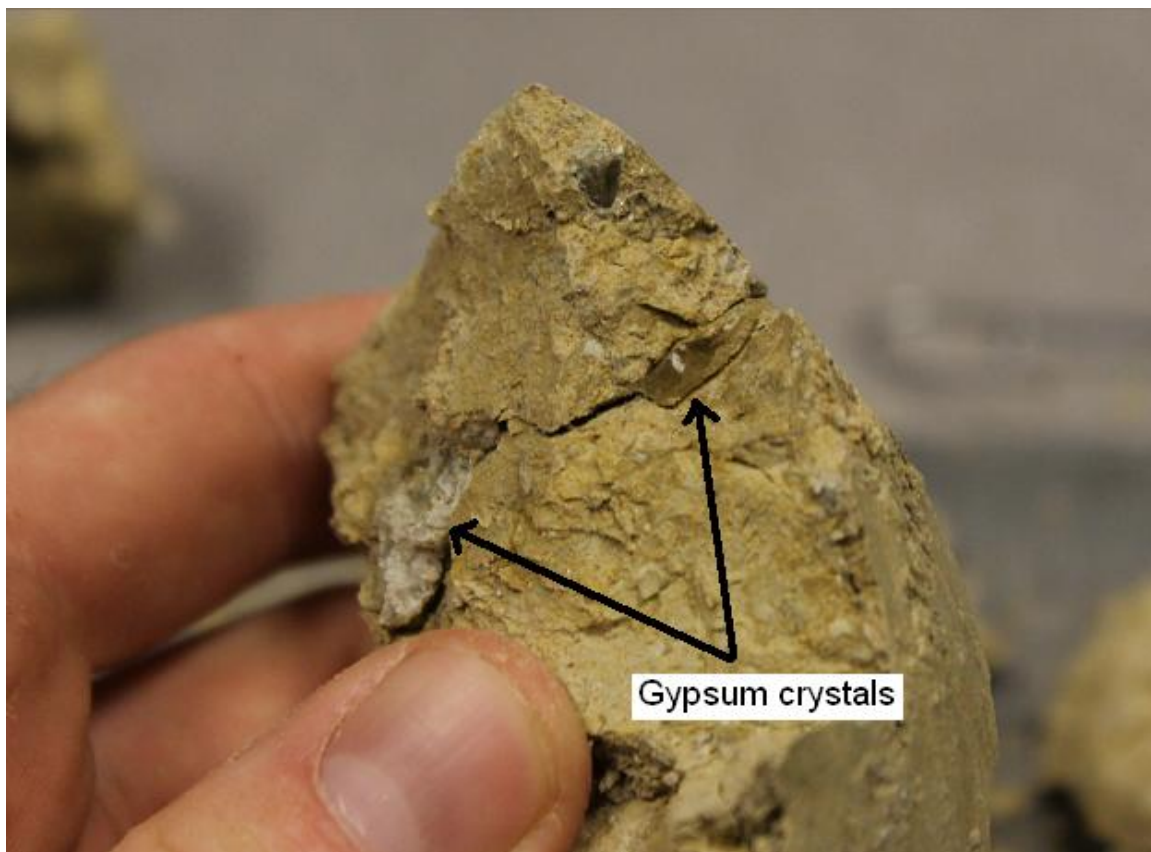
Figure 51: Gypsum crystals found in Boring 4-A.

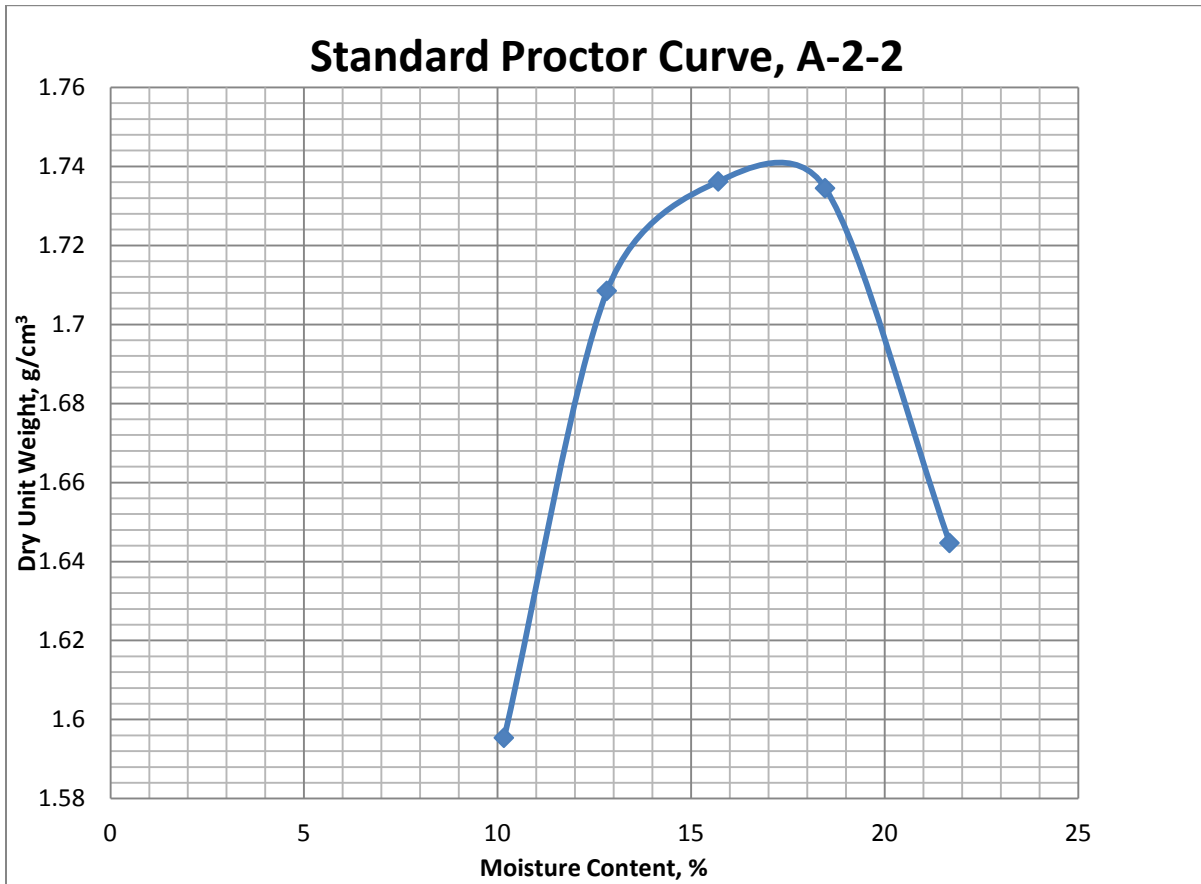
Figure 52: Standard Proctor Curve for sample A-2-2.
