**Analysis of Distress Along U.S. 331, Montgomery, AL
Between Mile Markers 88.480 and 91.070**

A thesis submitted to the Graduate Faculty of
Auburn University
in partial fulfillment of the
requirements for the Degree of
Master of Science

Auburn, Alabama
May 5, 2013

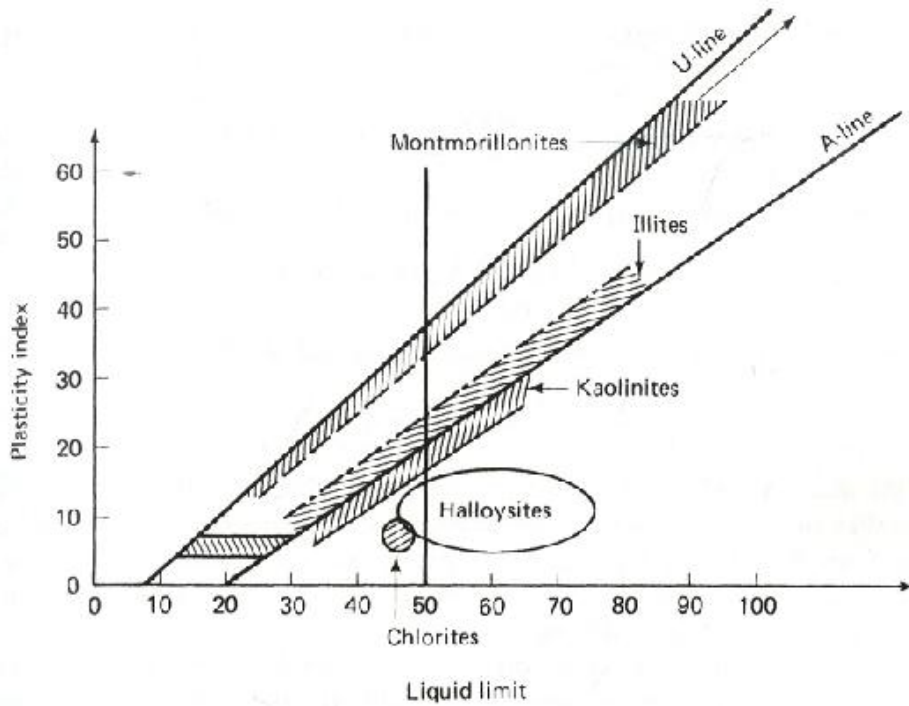
Figure 53: Relationship between Atterberg limits and mineral type (Casagrande 1948, Mitchell 1976).

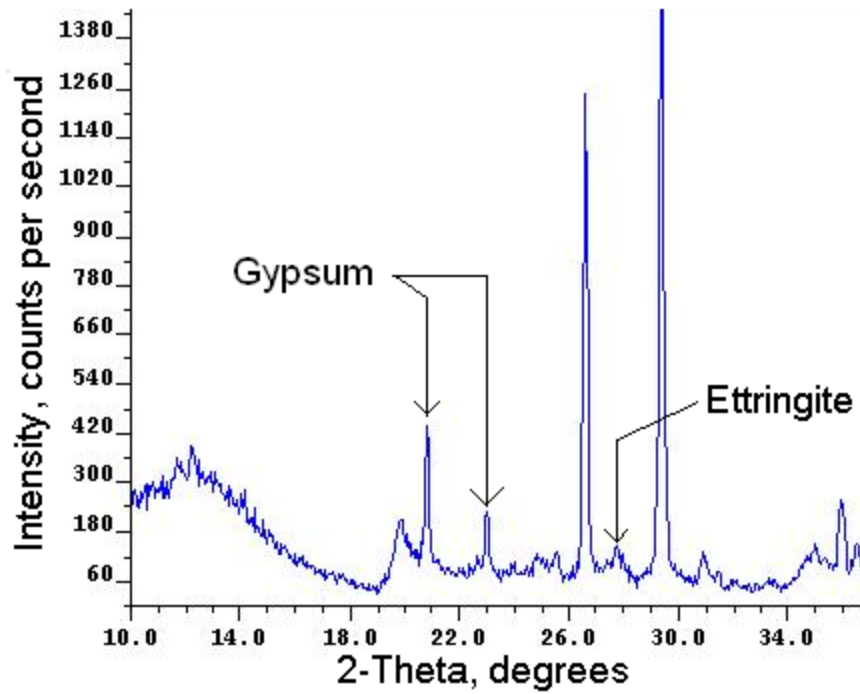
Figure 54: X-Ray diffraction results from sample 1-A, showing presence of ettringite and gypsum.

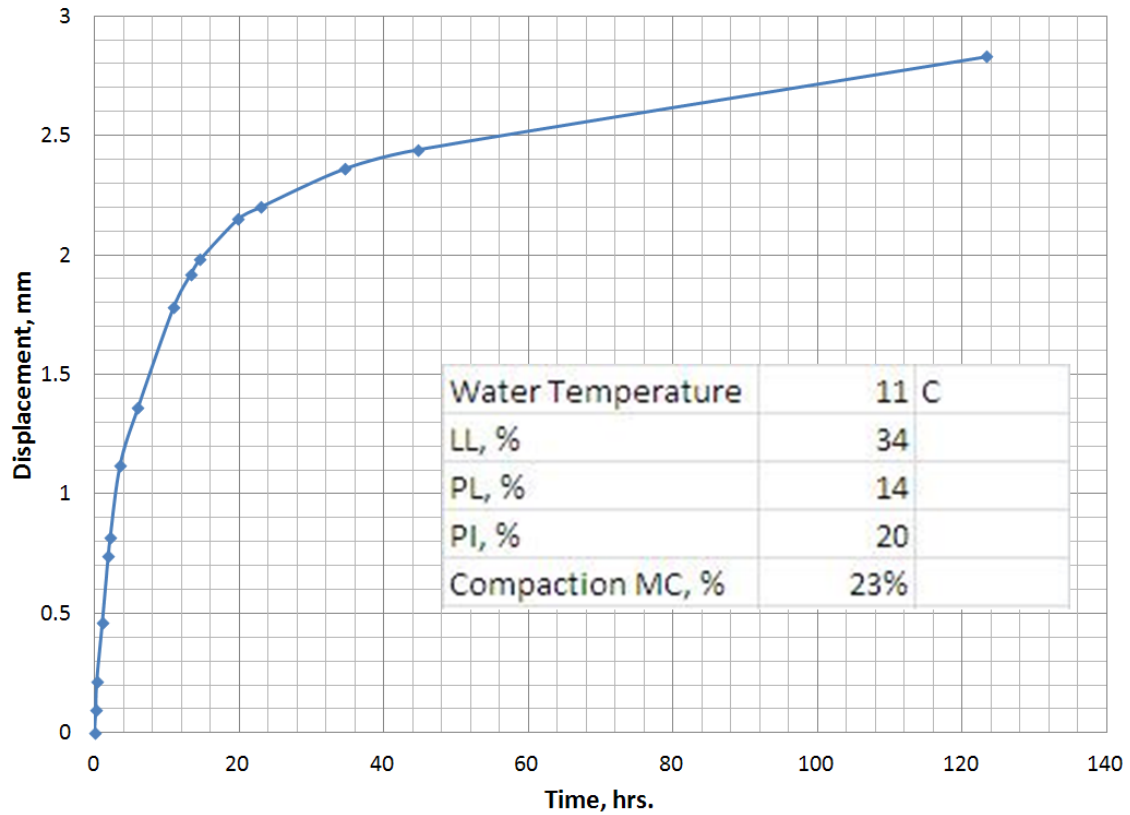
Figure 55: Swell test, Sample B-6. Peak swell =2.4%

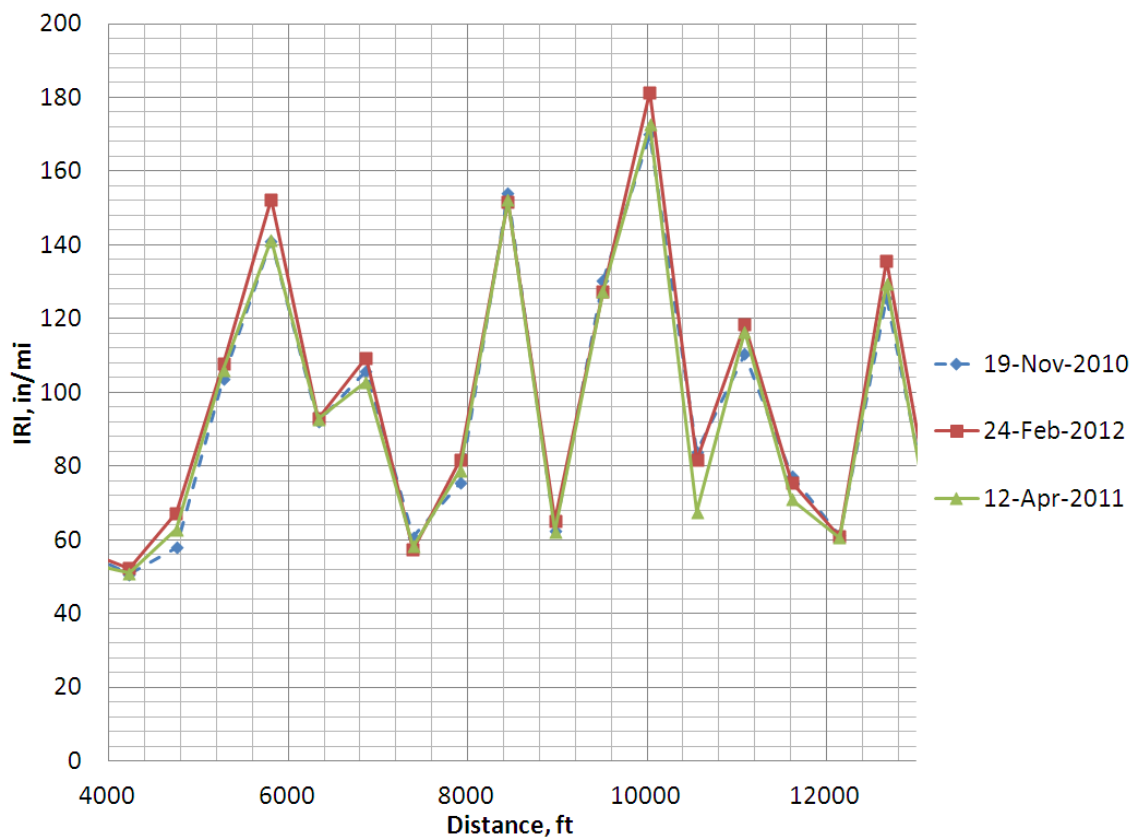
Figure 56: IRI data from northbound U.S. 331, right lane.

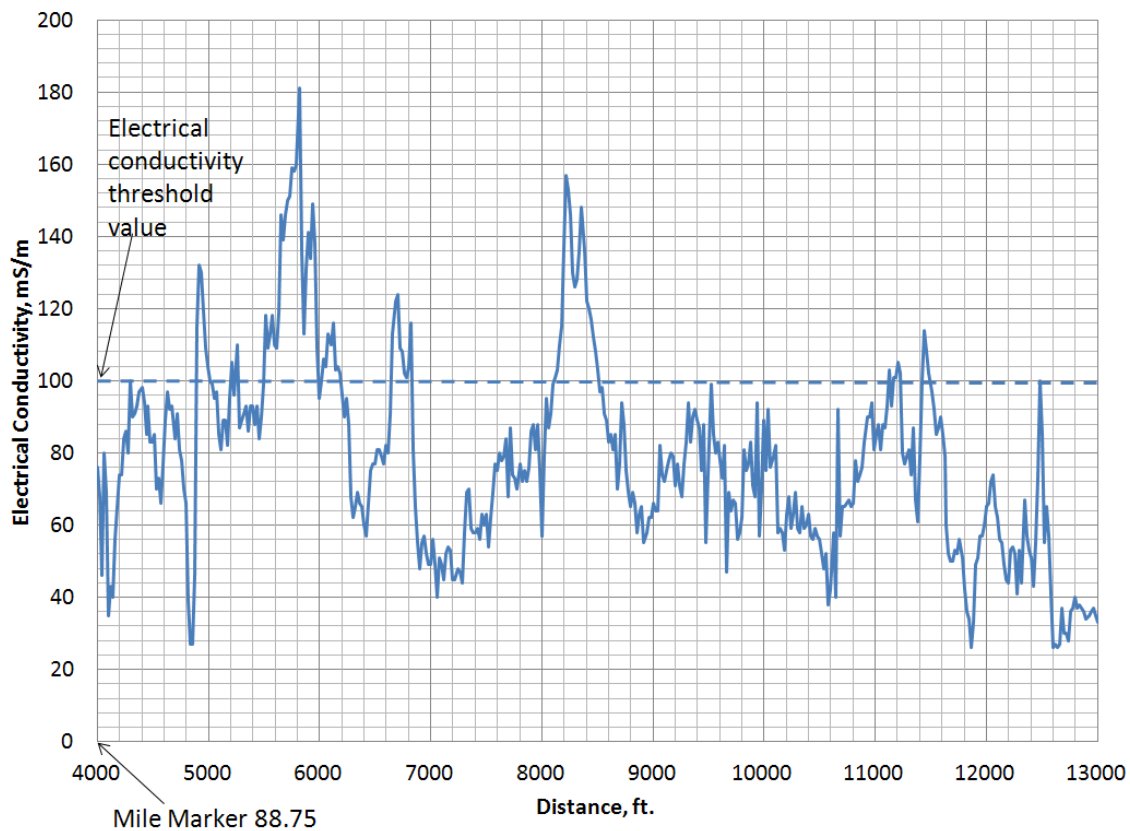
Figure 57: Electrical Conductivity vs. Linear Distance

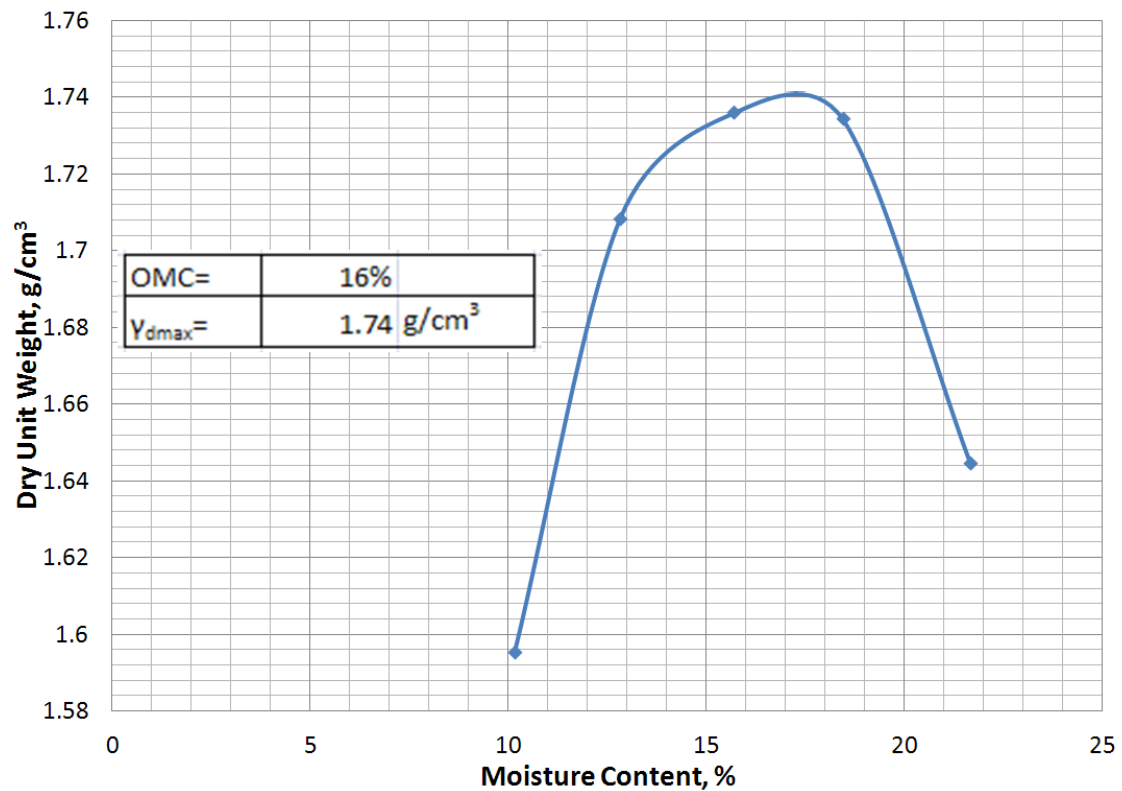
Figure 63: Standard Proctor curve, Sample A-2-2

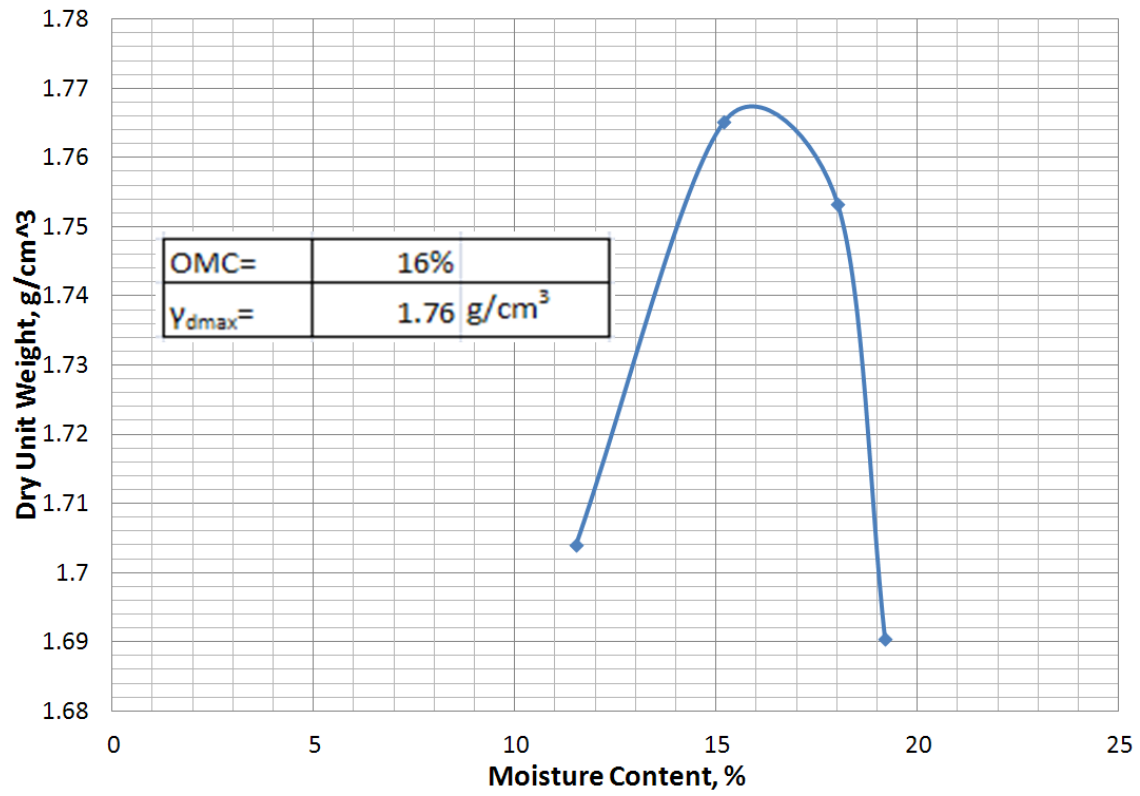
Figure 64: Standard Proctor curve, sample B-1

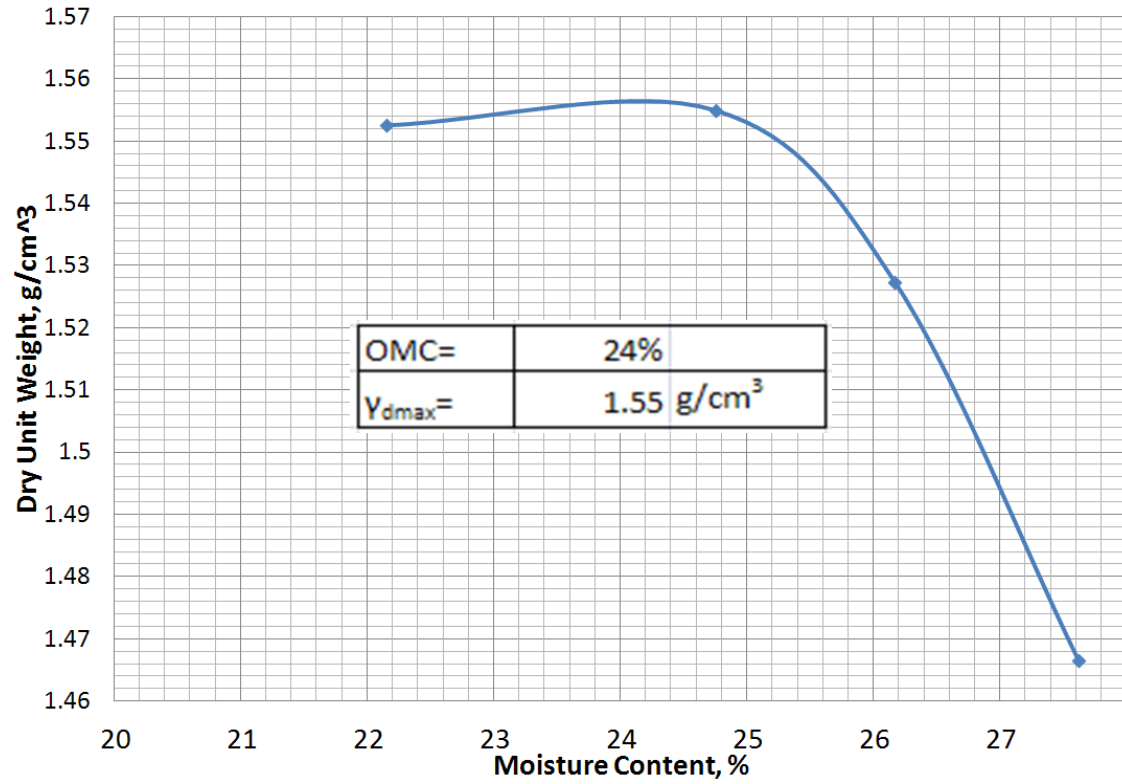
Figure 65: Standard Proctor curve, sample B-4

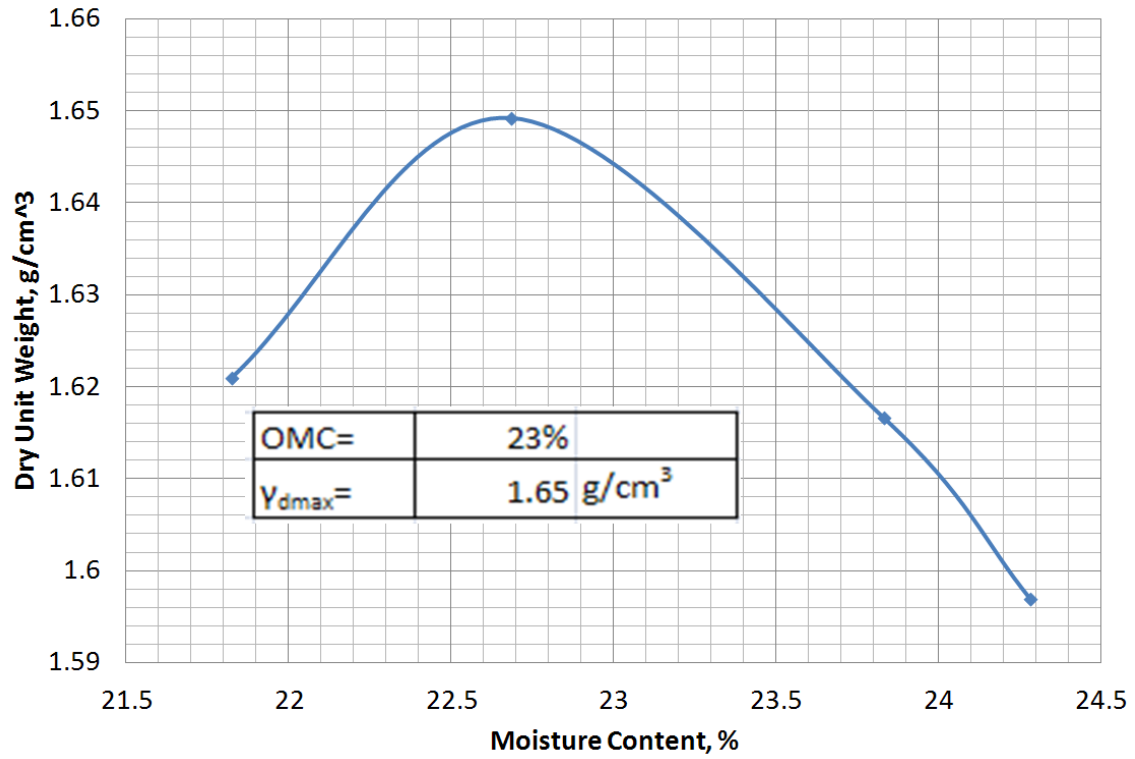
Figure 66: Standard Proctor curve, sample B-6

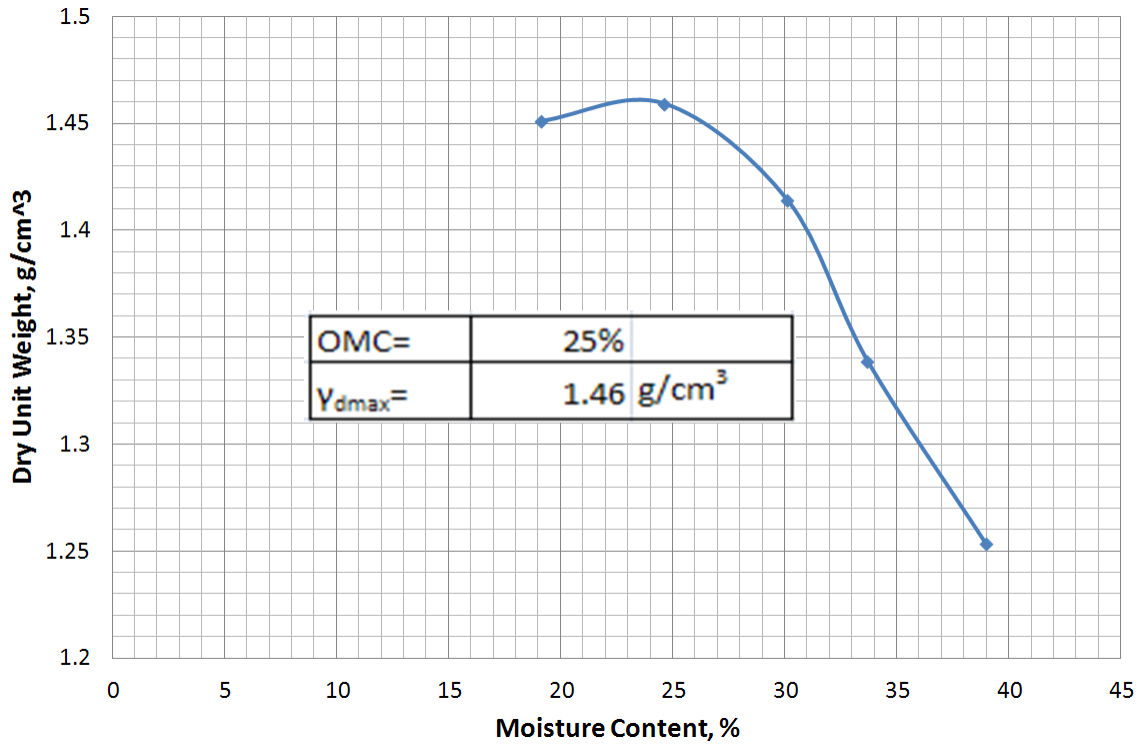
Figure 67: Standard Proctor curve, sample E-6

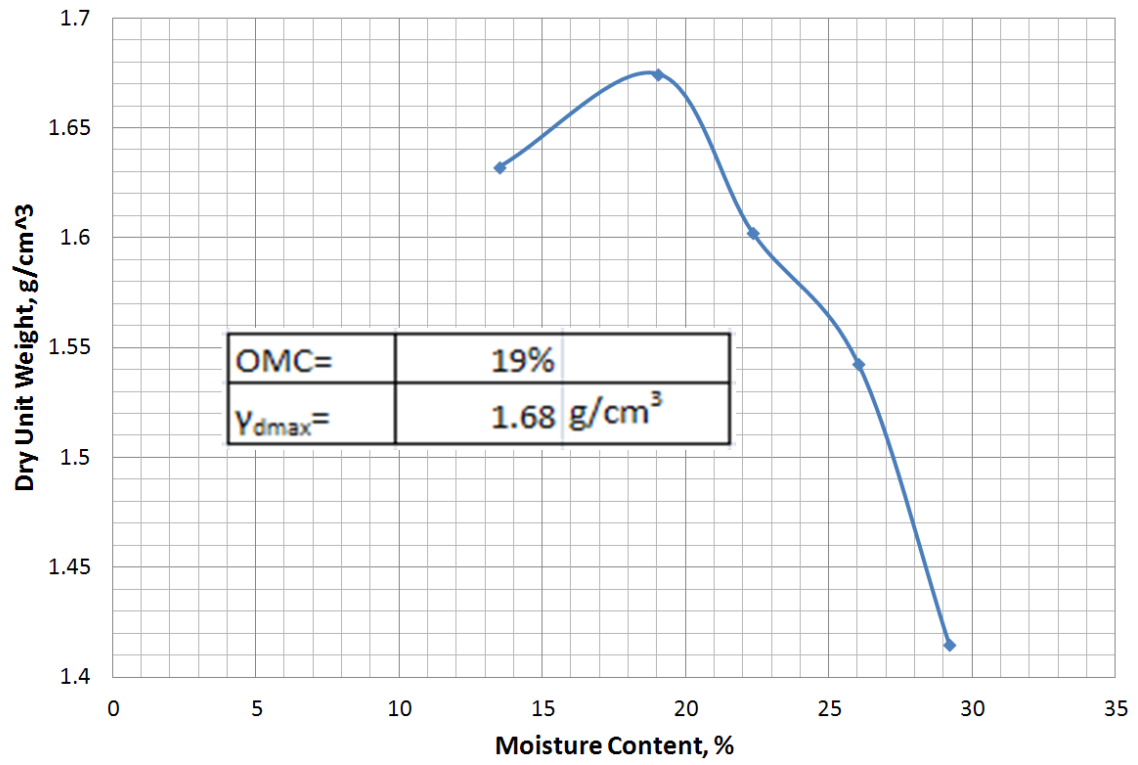
Figure 68: Standard Proctor curve, sample G-3

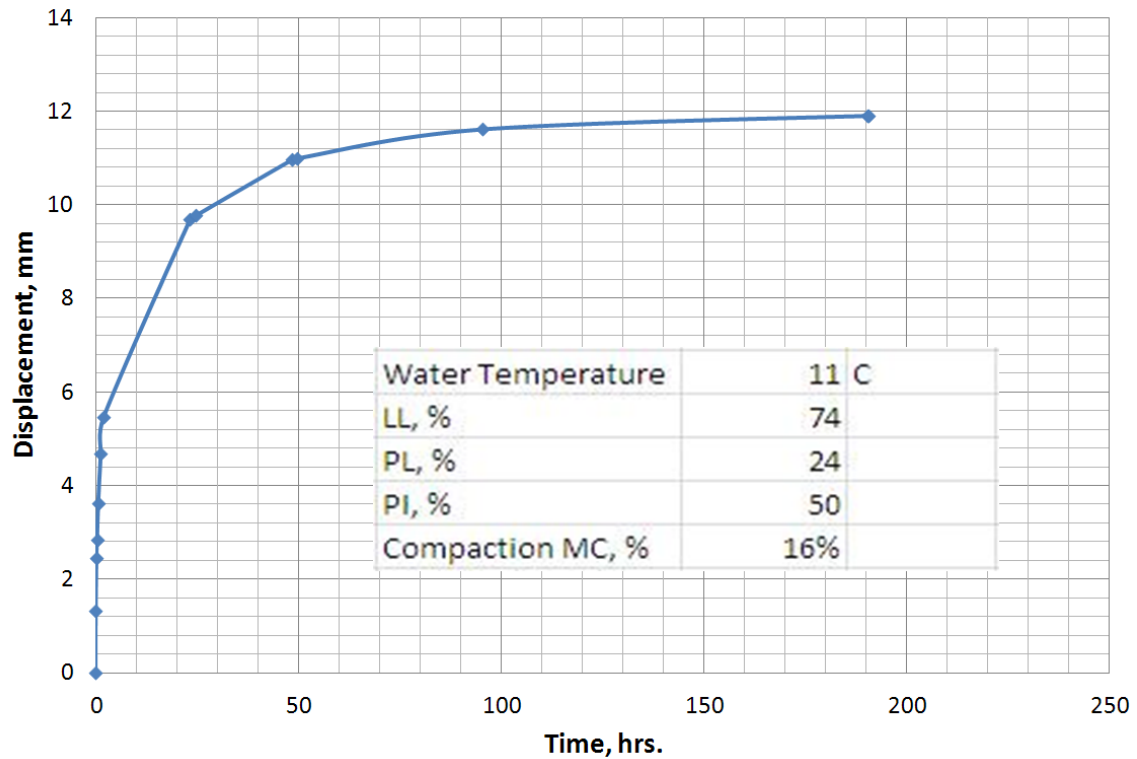
Figure 69: Swell test, Sample A-2-2. Peak swell =10.2%

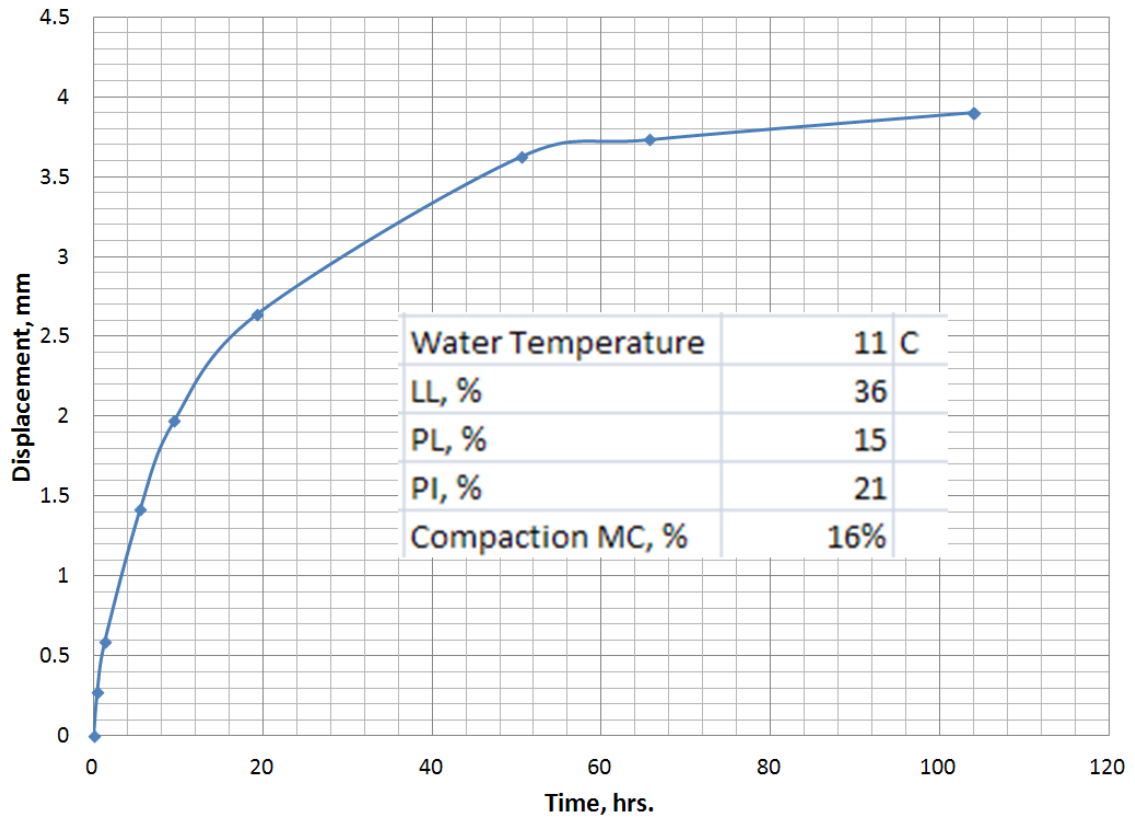
Figure 70: Swell test, Sample B-1. Peak swell =3.3%

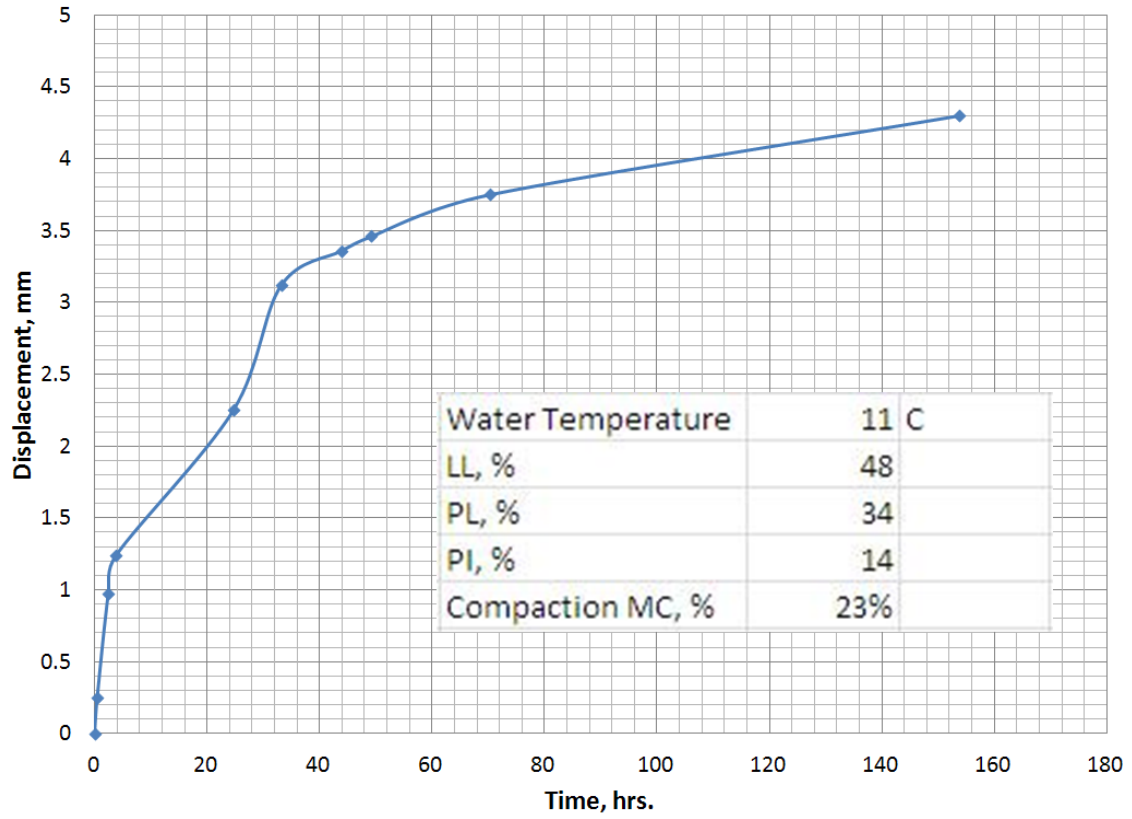
Figure 71: Swell test, Sample B-4. Peak swell =3.7%

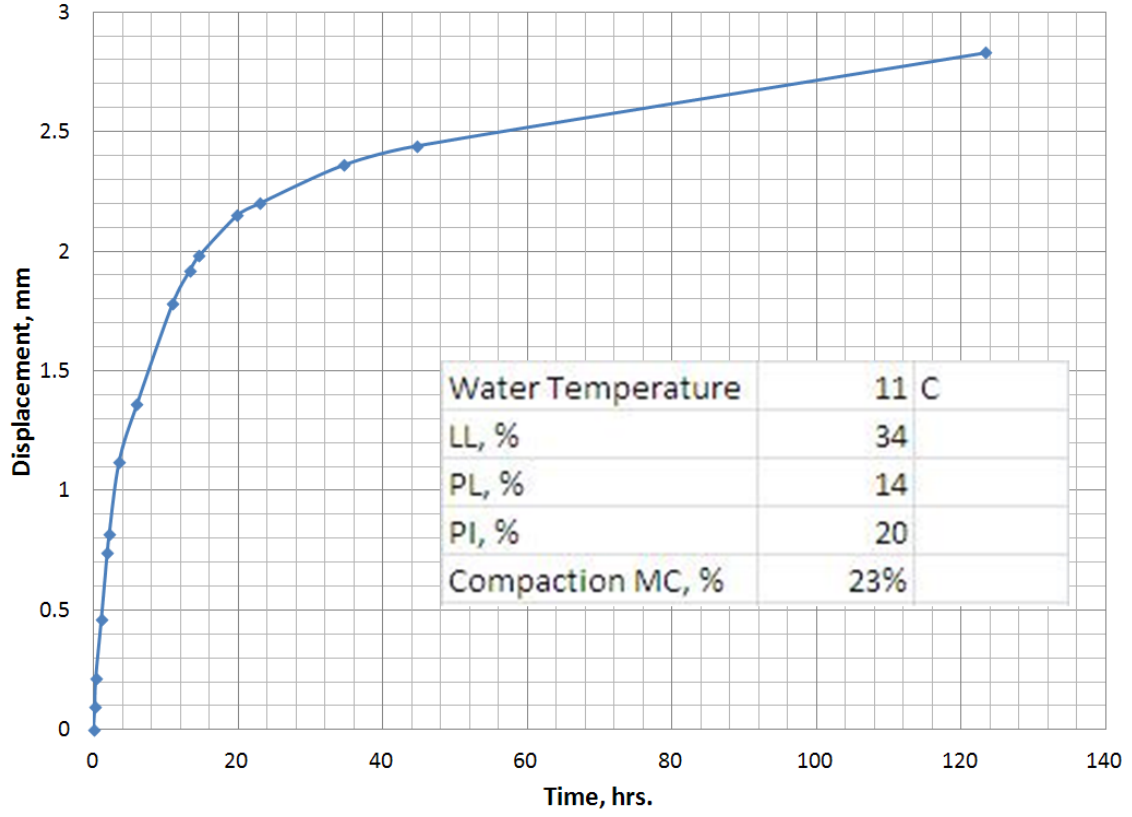
Figure 72: Swell test, Sample B-6. Peak swell =2.4%

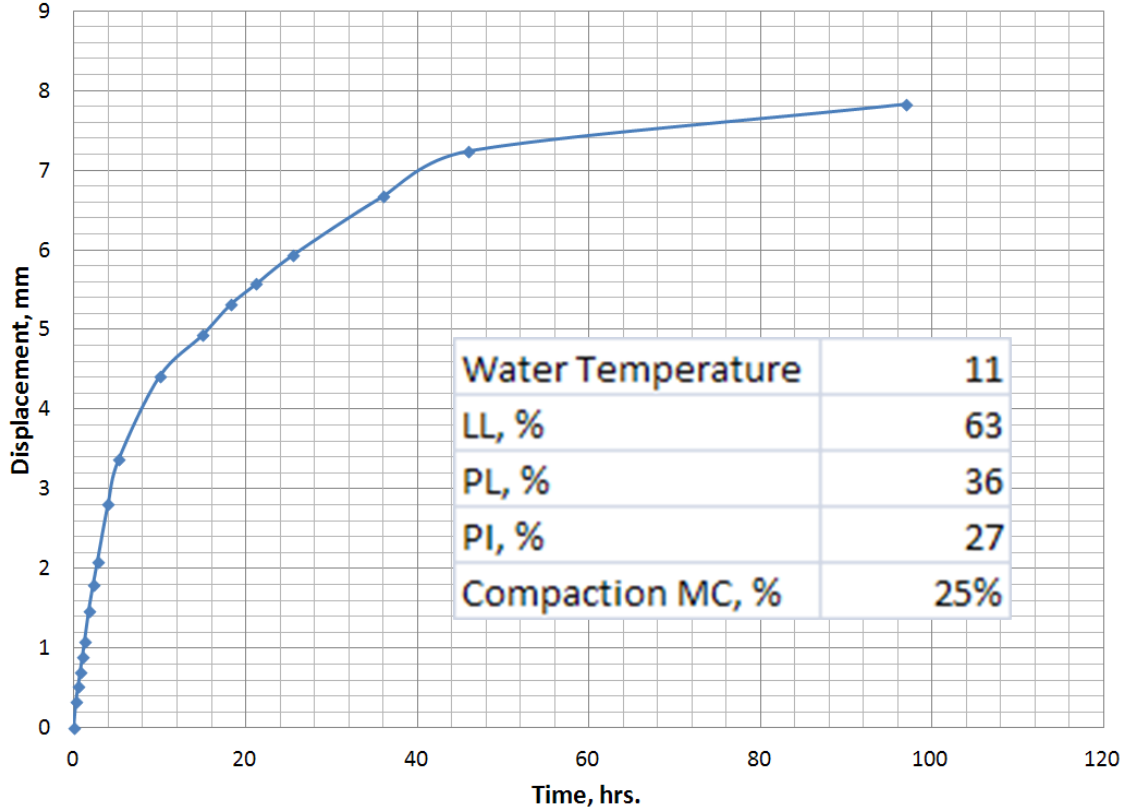
Figure 73: Swell test, Sample E-6. Peak swell =6.7%

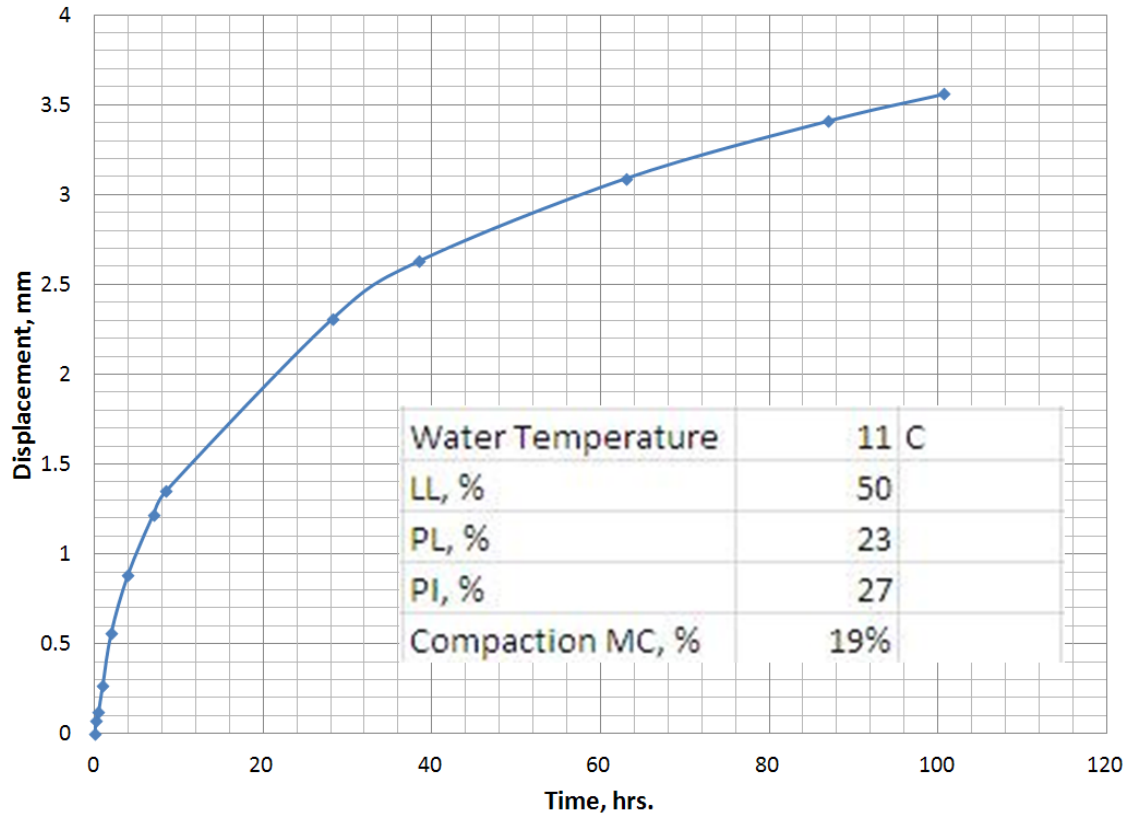
Figure 74: Swell test, Sample G-3. Peak swell =3.0%

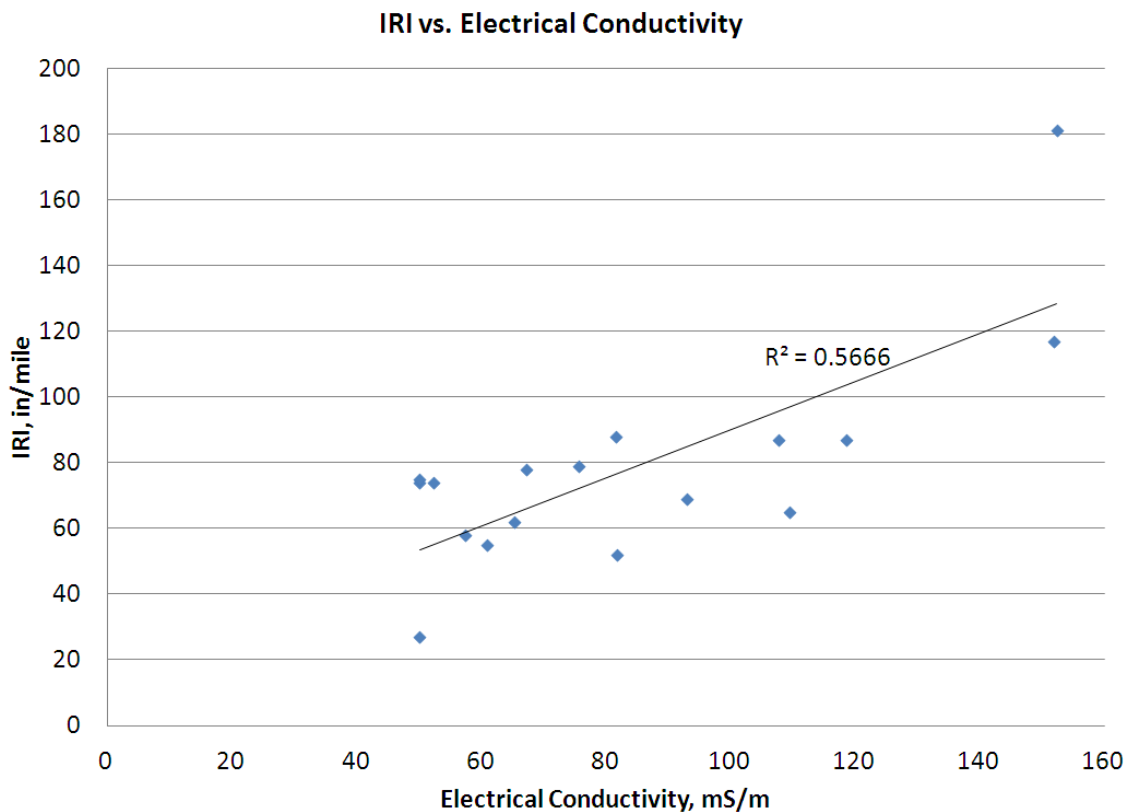
Figure 75: IRI vs. Electrical Conductivity

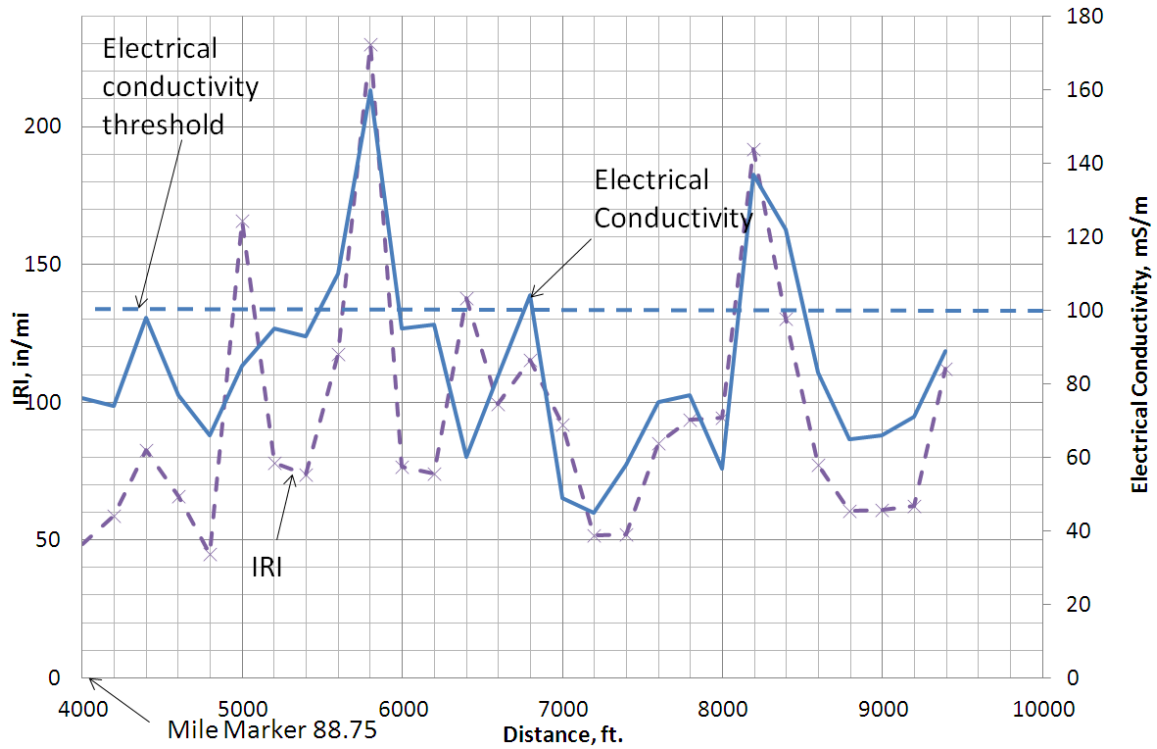
Figure 76: IRI and electrical conductivity vs. distance. The February 10, 2012 electrical conductivity test is represented by the solid line and the February 24, 2012 IRI test is represented by the dashed line.
